Technical Service Bulletin

Subject: REAR COMBINATION LIGHT(S) ARE FOGGY	Bulletin No.: 09-014/19
	Last Issued: 03/15/2019

2017-2018 CX-5 vehicles with VINs lower than JM3KF*****356208 (produced before Feb. 6, 2018)

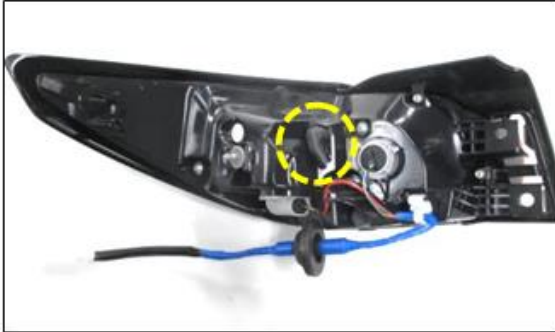
LIGHT UNIT, RIGHT

2. Remove the rear combination light unit according to the instructions on MGSS online (REAR COMBINATION LIGHT REMOVAL/INSTALLATION).
3. Remove the ventilation tube from the back of the light unit.

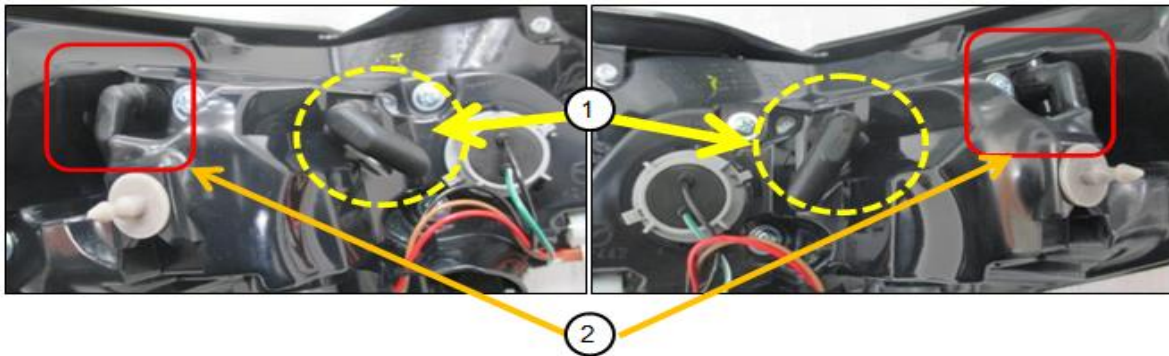
NOTE: Bulb type rear combination lights have two ventilation tubes. Remove only the inner ventilation tube (1). Do not remove the outer ventilation tube (2).

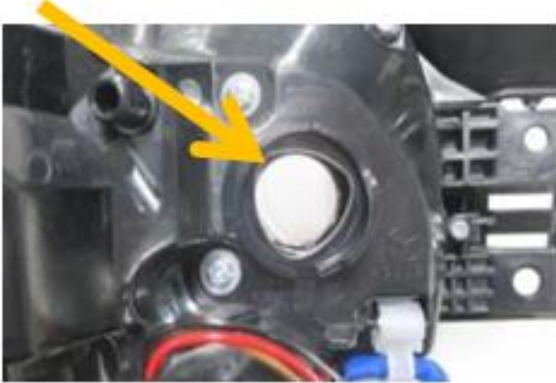
4. Turn the light bulb socket to remove it.

NOTE: Do not damage the bulb.

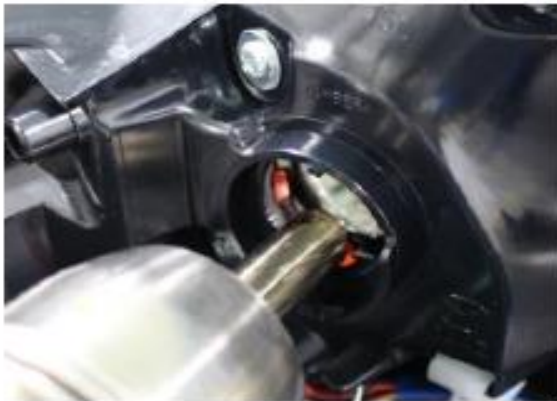
5. **Foggy Unit / No drops on lens:** Hold a dryer to the turn light bulb socket hole and blow **cold air** into the unit for 20 minutes to dry out the inside of the unit.

NOTE: **DO NOT** blow hot or warm air into the socket hole because it could deform the plastic parts.

6. **Non-Foggy Unit:** Hold a dryer to the turn light bulb socket hole and blow **cold air** into the unit for one (1) minute to ventilate the inside of the unit.

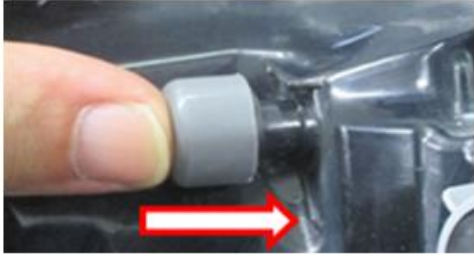
SIDE VIEW

8. Install the ventilation cap onto the rear combination light unit.

NOTE: Push the ventilation cap cover in parallel with the flange at the rear combination of the light housing. Push it 2mm away from the flange. If it is closer than 2mm, it may cause the problem to recur.
