## Technical Service Bulletin

| GROUP<br><b>CAMPAIGN</b> | NUMBER<br><b>19-01-004H</b> |

**SUBJECT:** TUCSON (TL) & IONIQ PLUG-IN HYBRID (AE PHEV) D-AUDIO LITE SOFTWARE UPDATE: BLANK HOME SCREEN (SERVICE CAMPAIGN T3R)

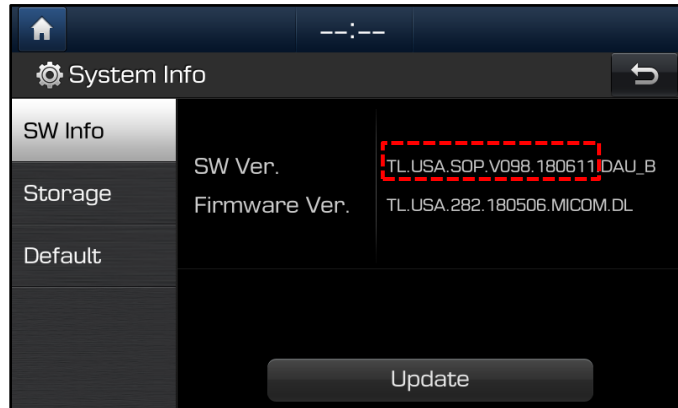
- 4. Confirm that the SW Version that's currently installed is out of date. If the SW version is older than listed below, proceed with the update.
