HYUNDAI Technical Service Bulletin	GROUP AUTOMATIC TRANSMISSION	NUMBER 19-AT-002H
	DATE FEBRUARY, 2019	MODEL ELANTRA SPORT (AD) 1.6T, TUCSON (TL) 1.6T, VELOSTER (FS) 1.6T
SUBJECT: DUAL CLUTCH TRANSMISSION CLUTCH REPLACEMENT AND TCU SOFTWARE UPDATE

Description: Certain vehicles (listed below) equipped with 7-speed Dual Clutch Transmission (DCT) may exhibit an abnormal vibration at low speeds. This bulletin outlines the procedures for diagnosing and replacing the Double Clutch, including a Transmission Control Unit (TCU) software update.

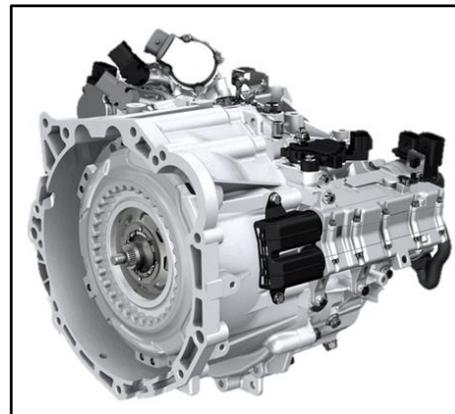
If no abnormal vibration is felt, the Double Clutch does not need to be replaced. The TSB procedure is complete; use the **Clutch Judder Inspection Only** OP-code (41200F02).

Clutch Replacement Procedure:

1. Remove the Dual-Clutch Transmission following the shop manual procedure.
2. Remove retaining ring (A) (41126-2D100) and the splined hub (B).
