GROUP <b>Product Improvement</b>	MODEL <b>See Model List on Page 1</b>
	NUMBER <b>PI1802W/X (Rev 2, 02/11/2019)</b>	DATE <b>October 2018</b>
<b>PRODUCT IMPROVEMENT CAMPAIGN</b>		
SUBJECT: <b>ENGINE REPLACEMENT INSTRUCTIONS FOR DTC P1326 (PI1802W/X)</b>

This bulletin provides information related to the Technical Service Bulletin previously published in July 2018 ([PI1802](#), Rev 6, 01/31/2019) titled “Knock Sensor Detection System - ECU Logic Improvement”. Specifically, this bulletin provides instructions on which procedures to follow if, after installation of the KSDS, any one of the subject vehicles below returns to the dealer with Diagnostic Trouble Code (“DTC”), P1326.

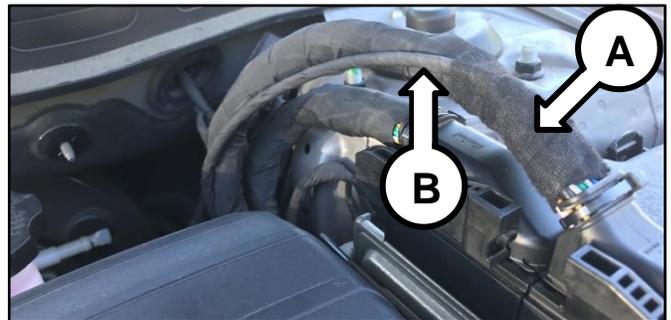
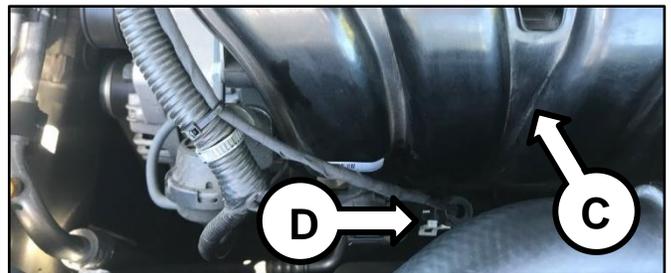
**NOTE:** To identify the extension harness (B), look for an external harness (B) which should be cable-tied to the existing wiring harness (A) leading by the intake manifold (C) to the knock sensor (D), as shown.

- If the extension harness (B) has been installed, open a Techline case online.
- If the extension harness (B) has not been installed, proceed to the next step.

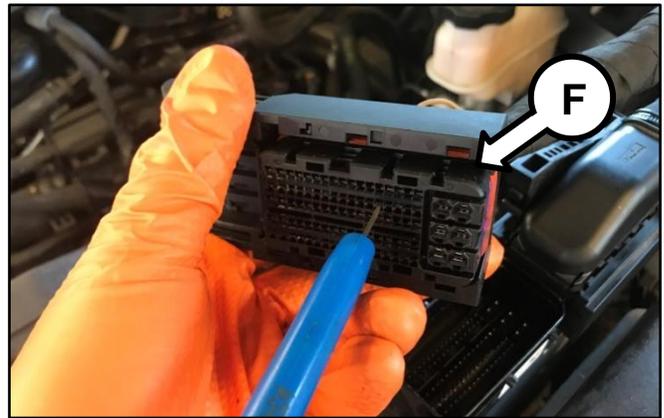
**NOTE:** Be sure to note the rotational position of the terminals during removal. They are directional and need to be reinstalled in the same “clock” position.

- Remove the three (3) terminals **one at a time** and insert the new terminals of the extension harness into the ECU connector (F). Reinstall pin retainer (K) and reassemble the connector (F).

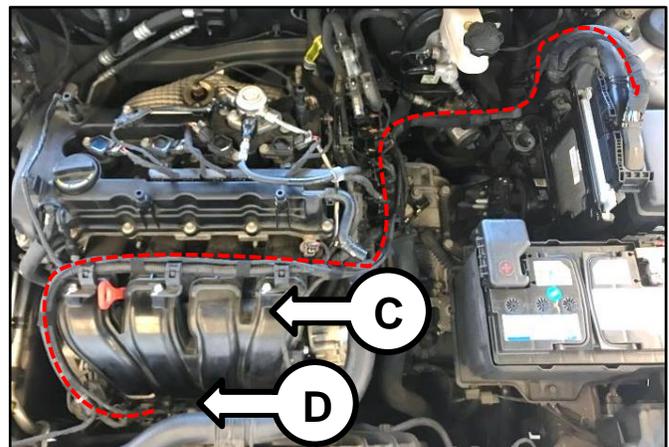
The harness (B) must be routed above and secured to the harness protector (L1) and **UNDER** the Breather Hose (L2) and Camshaft Position Sensor (L3).

- Route the extension harness (B) along the existing harness (A) leading by the intake manifold (C) to the knock sensor (D), as shown.
