MODEL  
2011-2014MY  
Optima (QF/TF)  
2012-2014MY  
Sorento (XMa)  
2011-2013MY  
Sportage (SL)

NUMBER  
PI1803W/X (Rev 2, 02/11/2019)

## PRODUCT IMPROVEMENT CAMPAIGN

SUBJECT: ENGINE REPLACEMENT INSTRUCTIONS  
FOR DTC P1326 (PI1803W/X)

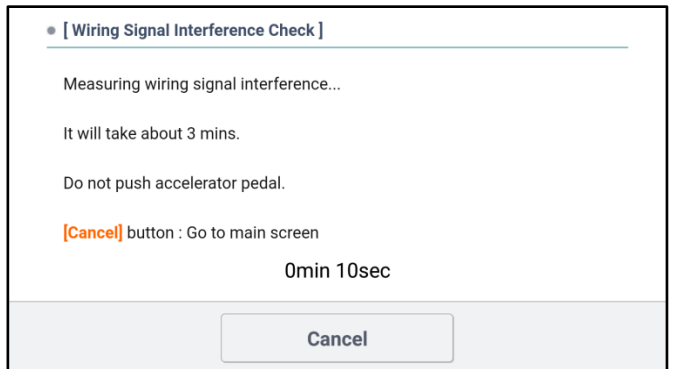
7. Wiring Signal Interference Check test will begin and take about three (3) minutes to complete. **NOTE:** Do not push on the accelerator pedal.

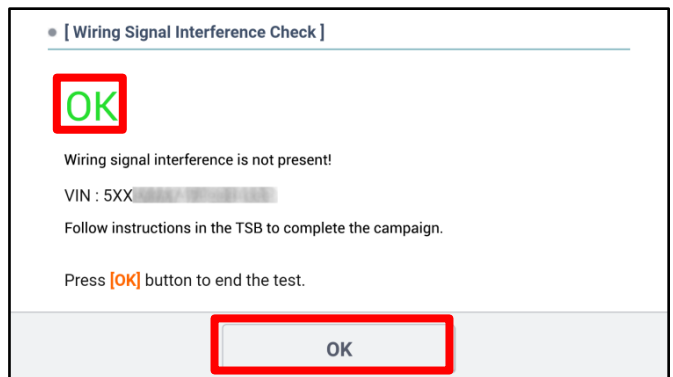
- If the result is “OK”, turn the engine off and proceed to the Engine Replacement procedure on page 9.

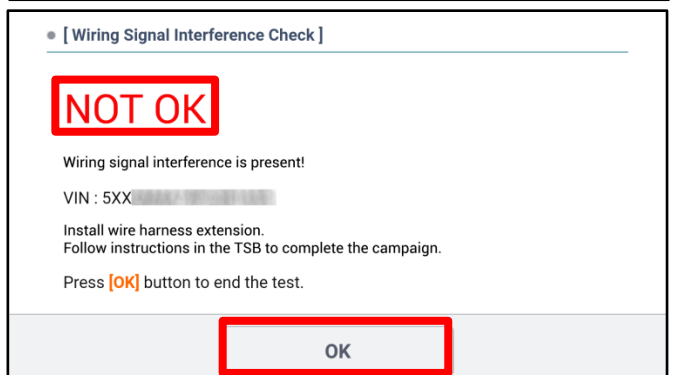
- If the result is “NOT OK”, turn the engine off and proceed to **step 2** of the Knock Sensor (KS) Extension Harness Installation procedure on page 5.

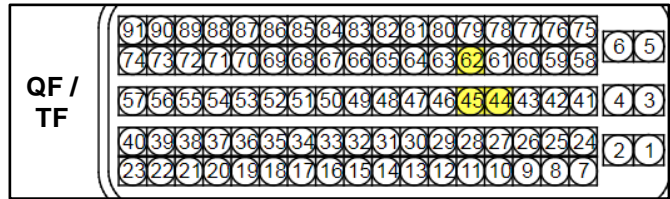
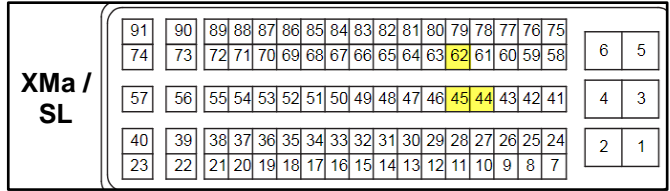
- 44. Knock Sensor Shielded Ground
- 45. Knock Sensor Ground
- 62. Knock Sensor Interface (Signal)

8. Locate the three (3) knock sensor circuit terminals from the ECU connector. Refer to the “Schematic Diagrams → Engine Electrical System → Engine Control System → Schematic Diagrams” chapter of the applicable ETM on KGIS.
