Service Bulletin

Bulletin No.: 16-NA-405

Subject: Poor Engine Performance in Extremely Cold Weather Conditions, PCV Bypass Hose and Charge Air Cooler Icing for LUV Engines, Malfunction Indicator Lamp (MIL) Illuminated - DTC P0299, P0236, P2227, P00C7 Set

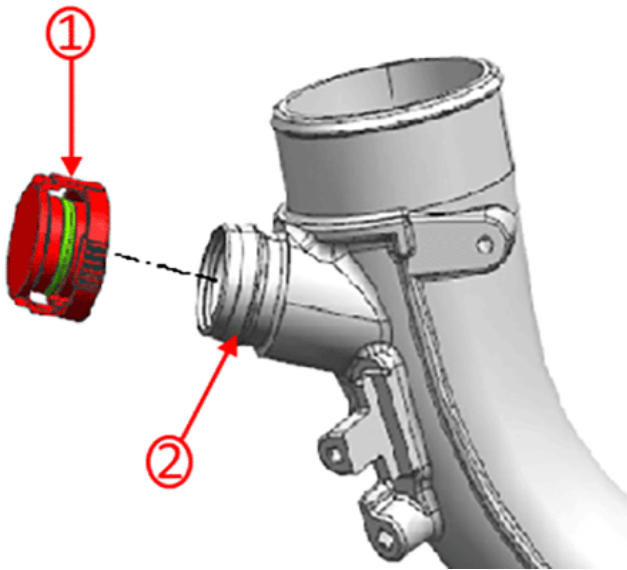
4377828

8. Inspect the IAPT sensor for any contaminants.

- 9. Allow time for any ice build-up to melt by placing the sensor port down.
- 10. Clean the sensor with a clean towel.
- 11. Install the IAPT sensor.
