Service Bulletin

Bulletin No.: PI1354I

Subject: Information on Vibration Analysis and Diagnostic

Models: 2014 Chevrolet Silverado 1500
2015-2018 Chevrolet Silverado 1500
2019 Chevrolet Silverado LD *
2014 GMC Sierra 1500
2015-2018 GMC Sierra 1500
2019 GMC Sierra Limited *
EXCLUDES HD Trucks

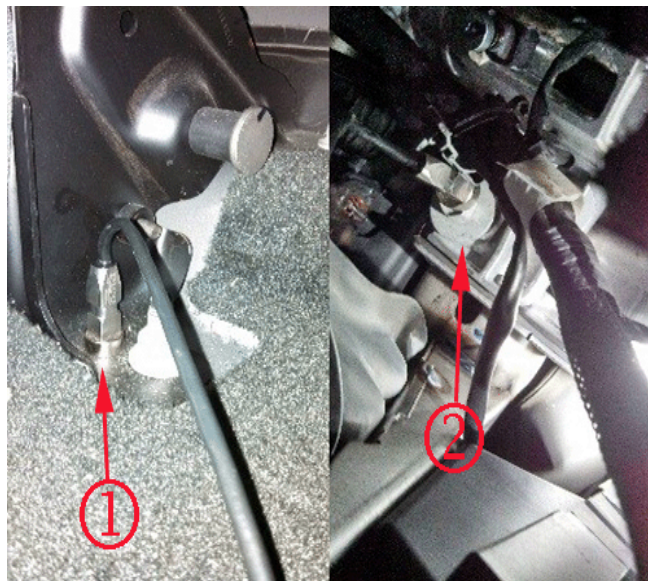
4002206

3. Using a Pico Oscilloscope Diagnostic Kit, mount the PicoScope vibration sensor on one of the two locations shown above.

- Seat Vibration – mount the sensor to the front right corner of the driver's seat bracket (1).
- Steering Wheel Vibration – mount the sensor to the steering wheel bracket (2) under dash.

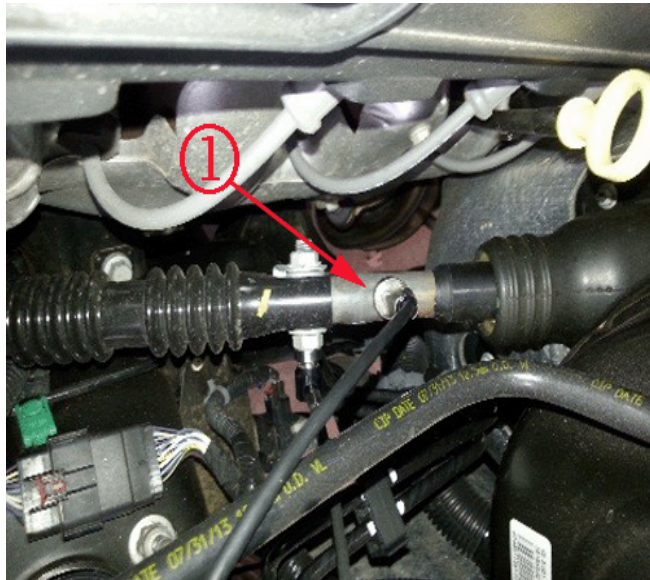
4002212

4. This step should be only be used if the vibration can be felt while running the vehicle on the rack. Mount the sensor on the steering shaft (1), under the hood as illustrated above.
5. Measure the vibration. Typically trucks should be driven in M5 for 6 speed applications and M7 for 8 speed applications to keep the engine from switching in and out of active fuel management (AFM).

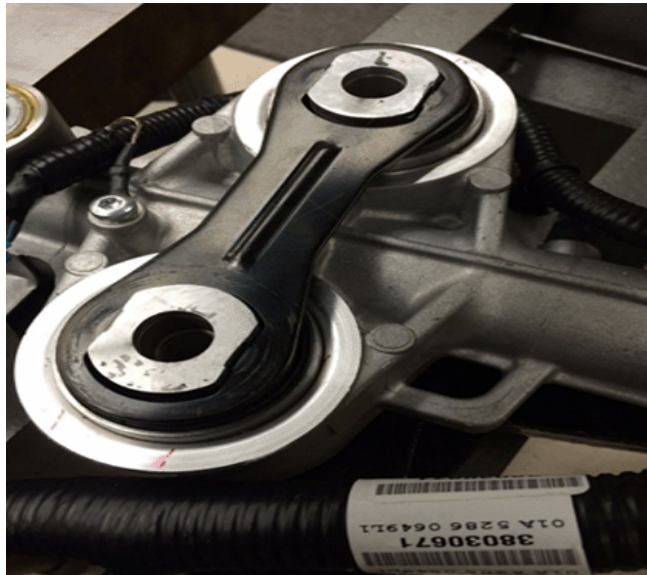
4728689

A revised steering bushing (2) has been released to address customer vibration concerns. After various testing and measurement of the T1 vibration, a vibration path from the tie rods =>steering rack=>steering bushings=>frame=>Body Mount=>Cabin Floor=>Seat has been identified. To help isolate the steering rack (1), a revised hydraulic bushing has been released and tuned to the T1 frequency. The new steering bushing dampens minor T1 vibrations. This is the reason that the causal part (normally the Tire/Wheel Assembly) must be corrected first. If the T1 vibration is over 20-25m/g's, the bushings will have little to no effect.

For vehicles with T1 vibrations under 20-25m/g's, replace steering bushing per parts catalogue. Utilize SI procedure "Steering Gear Mount Bushing Replacement" for replacement of the steering bushings.

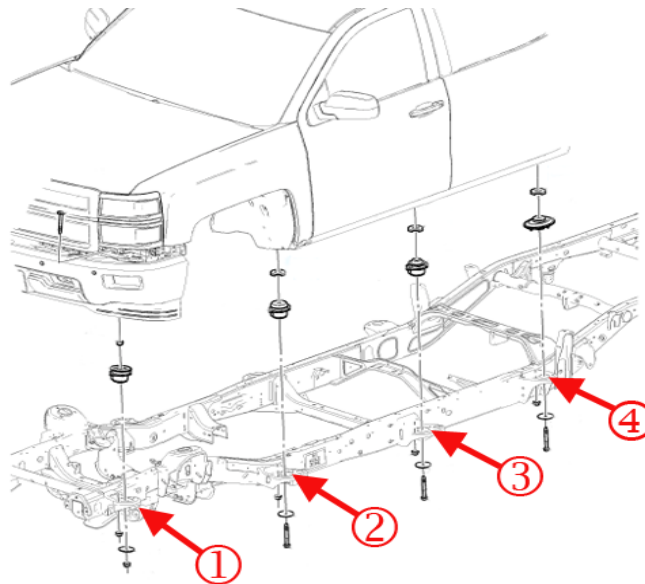
3996982

The numbers in the picture below indicate the specific mount position. The mounts on the passenger side of the vehicle are identified the same way. This will assist the technician to identify the correct location of each mount so they can be torque to the proper specification.

- 1 = body mount cushion front
 - 2 = body mount cushion position number 1
 - 3 = body mount cushion position number 2
 - 4 = body mount cushion position number 3
3. Pitchline runout – Pitchline runout will normally show as a 1st order tire vibration on the PicoScope. If after correcting tire(s) with excessive Road Force, a vibration exists, remove differential cover and check ring gear backlash. Every tooth should be checked for excessive backlash. If there is more than 0.0762 mm (0.003 in) of variation, the ring gear and/or differential should be replaced to correct the condition (SI Document ID# 3269088, 3620298) (PIP4148).

Visually verify that the cab to box alignment is correct before re-torquing all mounts to specification found in Service Information, body repair, frame and under body section.
