Lack of A/C Performance at Idle in High Ambient Temperature

Service Category Vehicle Interior

Section Heating/Air Conditioning

Some 2016 – 2019 model year Tacoma vehicles may exhibit a condition where the air conditioning system shuts down and stops blowing cool air during periods of extended engine idle with ambient temperatures greater than 100°F. Follow the Repair Procedure in the bulletin to address this condition.

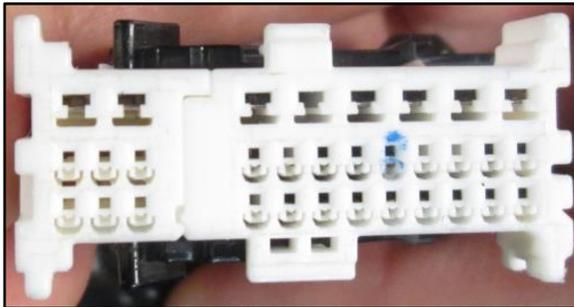
Figure 69.

- The connection of the NEW driver J/B sub-wire harness to the driver side J/B 1F connector will depend on whether there is a pin in pin location 16 of the 1F connector.
- For both manual and automatic A/C, the connection at the driver J/B will be made at pin location 16 of connector 1F.

Is there a pin and wire in pin location 16 of the 1F connector?

- **YES** — Continue to step 42 for the wire splice connection procedure.
- **NO** — Go to step 43 for the pin insertion procedure.

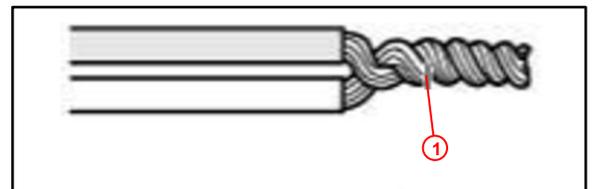
1 Wires Twisted Together Uniformly – Good

- H. Twist the two stripped wire ends together uniformly.

Due to the wire gauge size differences between the two wires, ensure the wire ends twist around each other evenly.

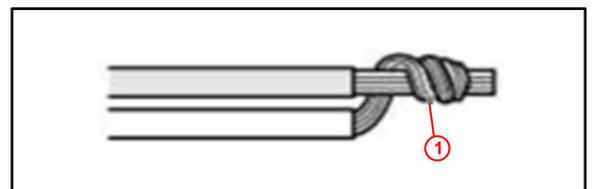
Figure 77.

1 Thin Wire Twisted Around Thick Wire – Not Good

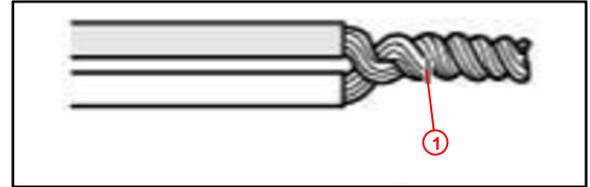
Figure 131.

1	Wires Twisted Together Uniformly – Good
---	---

- H. Twist the two stripped ends together uniformly.

Due to the wire gauge size differences between the two wires, ensure the wire ends twist around each other evenly.

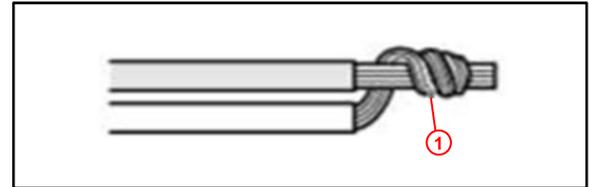
Figure 132.

1	Thin Wire Twisted Around Thick Wire – No Good
---	---

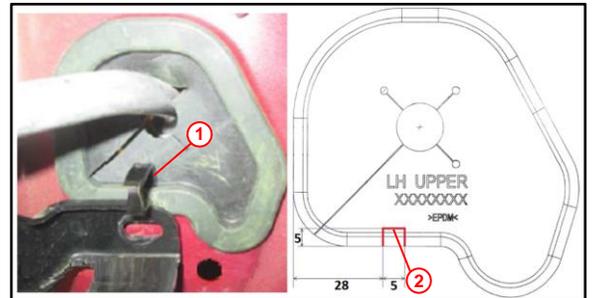
Figure 152.

Some vehicles may require modification to the upper left-hand body plug to allow clearance for the metal tab.

1	Metal Tab
2	Metal Tab Clearance Modification

- A. Install the two NEW left-hand body plugs in the indicated locations on the left side of the radiator core support.
