Service Action

Code: 1906

Subject	Coolant Bottle
Release Date	February 27, 2019
Affected Vehicles	U.S.A. & CANADA: Certain 2018 MY Volkswagen Atlas <i>Check Campaigns/Actions screen in Elsa on the day of repair to verify that a VIN qualifies for repair under this action. Elsa is the <u>only</u> valid campaign inquiry & verification source.</i> <ul style="list-style-type: none">✓ Campaign status must show "open."✓ If Elsa shows other open action(s), inform your customer so that the work can also be completed at the same time the vehicle is in the workshop for this campaign.
Problem Description	The coolant level sensor may leak coolant through the electrical connector.
Corrective Action	Replace the coolant bottle and inspect coolant level sensor wiring connector.
Parts Information	Parts will be allocated prior to owner notification. If allocated parts have been used, please contact the Parts Specialists via phone (800-767-6552), email (VWoAPartsSpecialists@vw.com) or chat/text with the VIN to order.

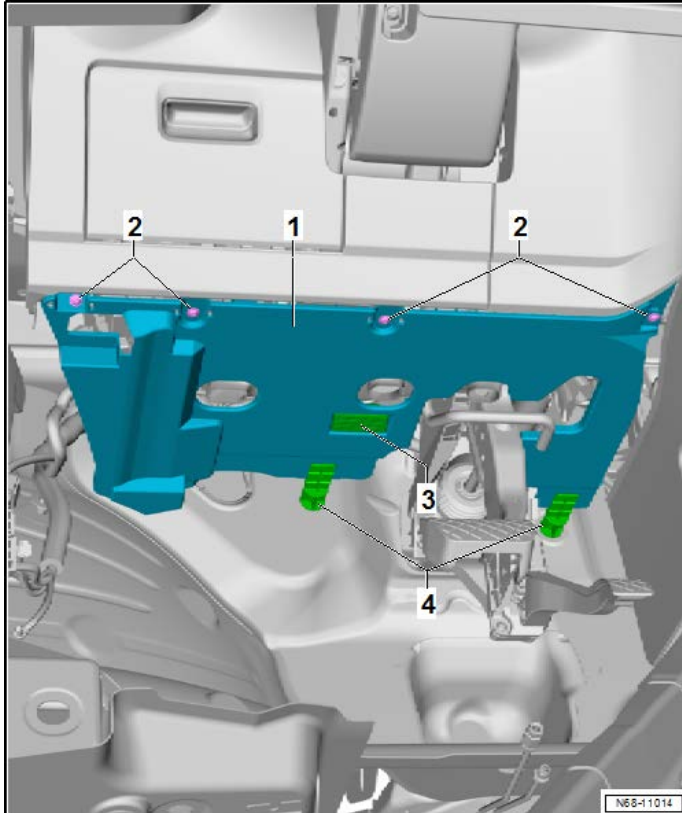
Section C – Coolant Migration Inspection

Inspect for coolant at Vehicle Electrical System Control Module -J519- connector:

- Remove securing pins <2>.
- Lower the driver side instrument panel lower cover <1> slightly in the rear area.
- Remove the driver side instrument panel cover <1> out of the guides <4>.
- Disconnect the footwell lamp connector <3>.
