Complaint - Cylinder Head Cover Near the Injector Holes Leaking: Subsequent work on cylinder head (180/18)

Model Line: **Cayenne (9YA) — LK2/LK3**

Model Year: **As of 2017 up to 2019**

Subject: **Cylinder head cover**

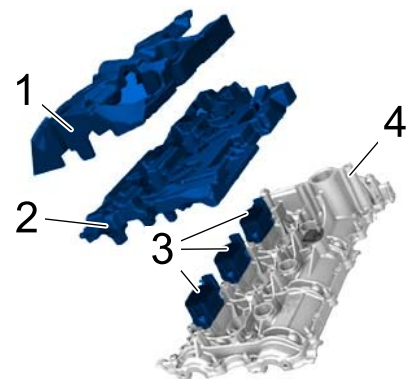
Component overview of cylinder head cover

- Due to a batch error in the casting procedure there may be cast residue in the cylinder head cover sealing groove.
- This cast residue may cause the injector holes to leak.

- 1** – Insulation on top of cylinder head cover
- 2** – Insulation on bottom of cylinder head cover
- 3** – Solenoid hydraulic valve for valve lift adjustment
- 4** – Cylinder head cover
