**Complaint - Cylinder Head Cover Near the Injector Holes Leaking: Subsequent work on cylinder head (180/18)**

Model Line: **Panamera (971) — LK2/LK3**

Model Year: **As of 2017 up to 2019**

Information: **Complaint about injector hole leaks**

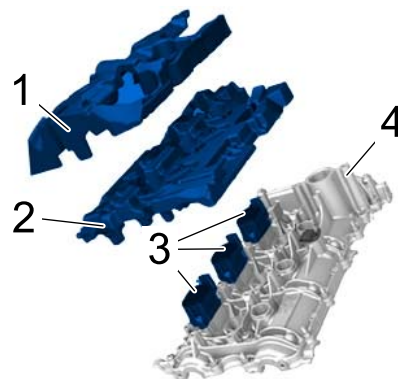
*Component overview of cylinder head cover*

- 1** – Insulation on top of cylinder head cover
- 2** – Insulation on bottom of cylinder head cover
- 3** – Solenoid hydraulic valve for valve lift adjustment
- 4** – Cylinder head cover
