# Service Action

## Code: 92D9

<b>Subject</b>	<b>Rain/Light/Humidity Sensor - USA Only</b>
<b>Release Date</b>	February 14, 2019
<b>Affected Vehicles</b>	<b>U.S.A.: Certain 2019 MY Volkswagen Jetta</b> <i>Check Campaigns/Actions screen in Elsa on the day of repair to verify that a VIN qualifies for repair under this action. Elsa is the <u>only</u> valid campaign inquiry &amp; verification source.</i> <ul style="list-style-type: none"><li>✓ Campaign status must show "open."</li><li>✓ If Elsa shows other open action(s), inform your customer so that the work can also be completed at the same time the vehicle is in the workshop for this campaign.</li></ul>
<b>Problem Description</b>	A humidity sensor installed in affected vehicles deactivates the start-stop feature when the Climatronic system is turned on.
<b>Corrective Action</b>	Replace the affected humidity sensor with a rain/light/humidity sensor.
<b>Parts Information</b>	Due to this being a service part, there will be no parts allocation. Parts will be placed on Upper Order Limits. If your dealership is at the weekly Upper Order Limit, please submit the backordered sales document number to <a href="mailto:upperorderlimits@VW.com

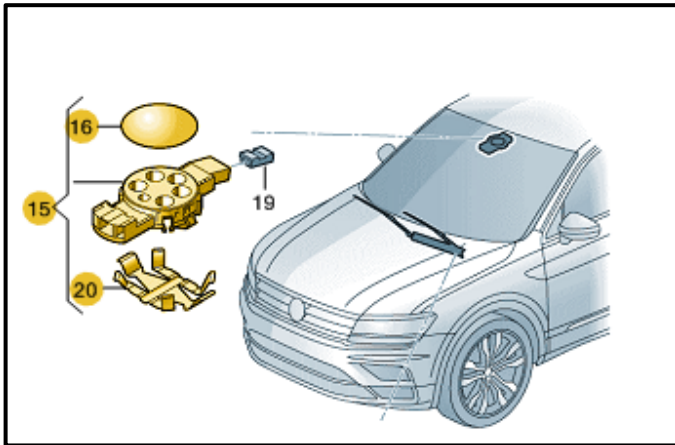
**Repair Overview**

**What is the issue?** A humidity sensor installed in affected vehicles deactivates the start-stop feature when the Climatronic system is turned on.

- Install new rain/light/humidity sensor.
