# Service Bulletin

Bulletin No.: 16-NA-405

Date: April, 2019

**Subject:** Poor Engine Performance in Extremely Cold Weather Conditions, PCV Bypass Hose and Charge Air Cooler Icing for LUV Engines, Malfunction Indicator Lamp (MIL) Illuminated - DTC P0299, P0236, P2227, P00C7 Set

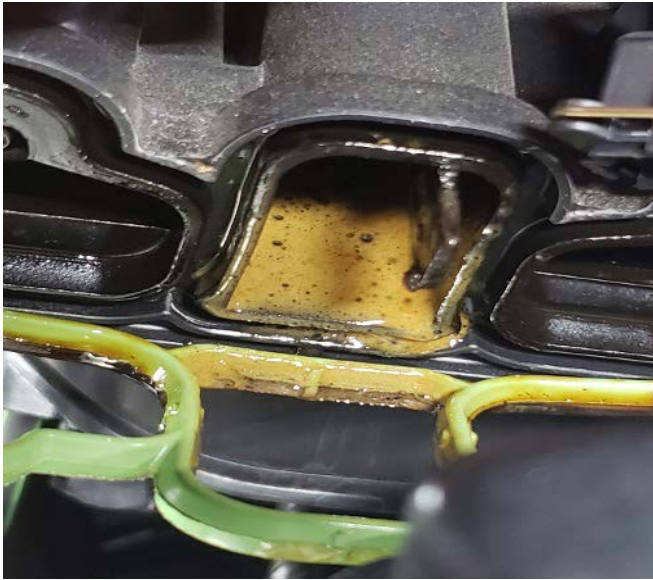
5286568

3. Inspect the PCV intake runner for ice build-up blocking the cylinder head as shown above.

4. Clean any ice/sludge/water/carbon out of the PCV pipes/hoses, the PCV nipple on the intake manifold, the PCV intake runners and the orifice between the #2 and #3 intake ports.
5. Install the intake manifold.

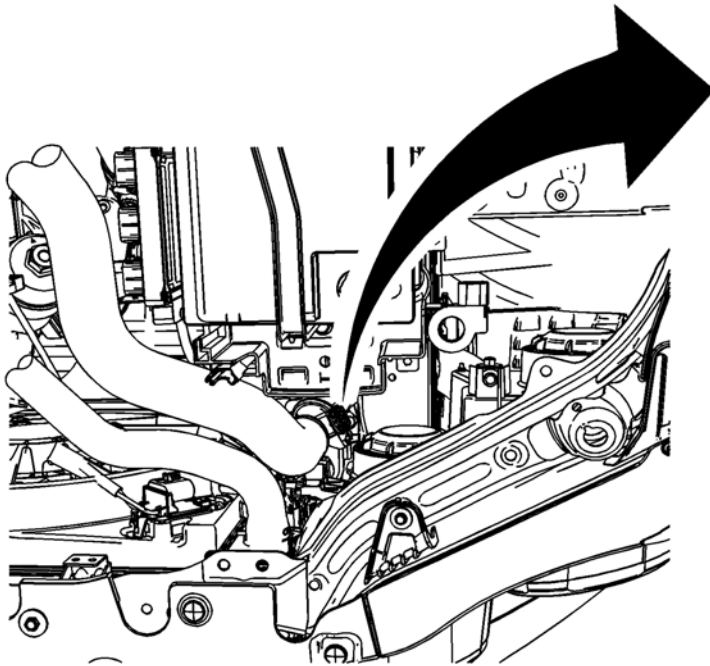
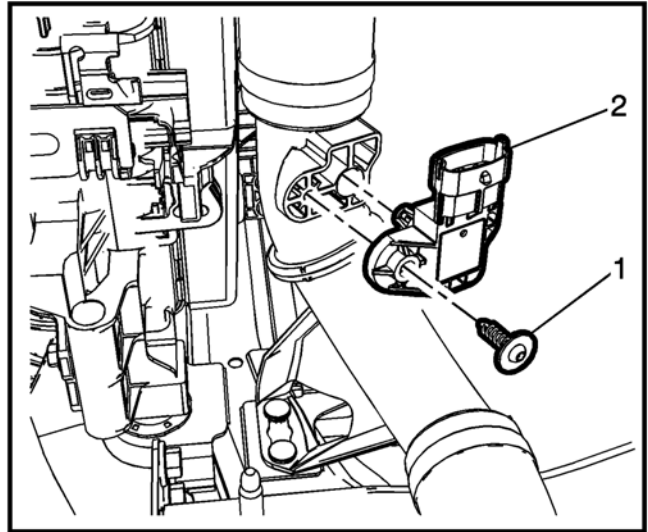
4910635

2. Inspect the IAPT sensor for any contaminates.

1. Remove the Intake Air Pressure and Temperature sensor (IAPT) (2). Refer to *Intake Air Pressure and Temperature Sensor Replacement* in SI.

3. Allow time for any ice build-up to melt by placing the sensor port down.
4. Clean the sensor with a clean towel.
5. Inspect the IAPT sensor for any contaminates.
