SI B35 01 19  
Pedals

## SERVICE ACTION: CHECK ROUTING OF ACCELERATOR PEDAL MODULE (PWG) WIRING HARNESS

G29 (Z4)

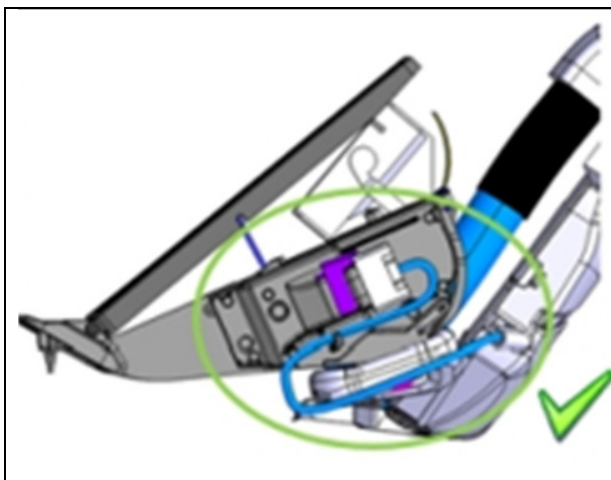
- Check the routing of the wire harness as per the illustration on the left (blue harness)
- Correct the harness routing if needed
