| | GROUP Product Improvement | MODEL See Model List on Page 1 |
| | NUMBER PI1803W/X (Rev 3, 04/03/2019) | DATE November 2018 |
| PRODUCT IMPROVEMENT CAMPAIGN | | |
| SUBJECT: ENGINE REPLACEMENT INSTRUCTIONS FOR DTC P1326 (PI1803W/X) | | |

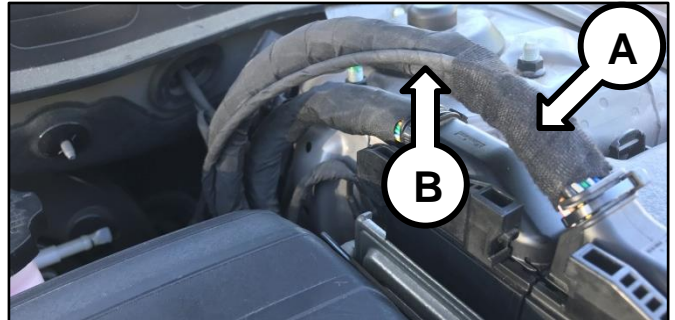
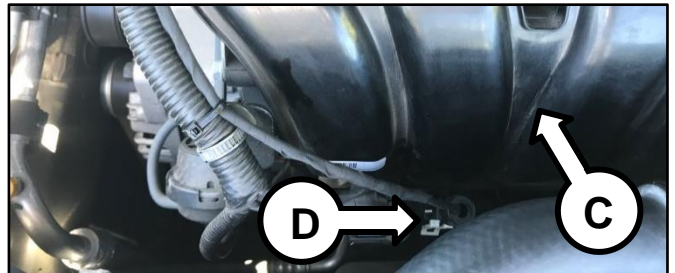
NOTE: To identify the extension harness (B), look for an external harness (B) which should be cable-tied to the existing wiring harness (A) leading by the intake manifold (C) to the knock sensor (D), as shown.

- If the extension harness (B) has been installed, open a Techline case online.
- If the extension harness (B) has not been installed, proceed to the next step.

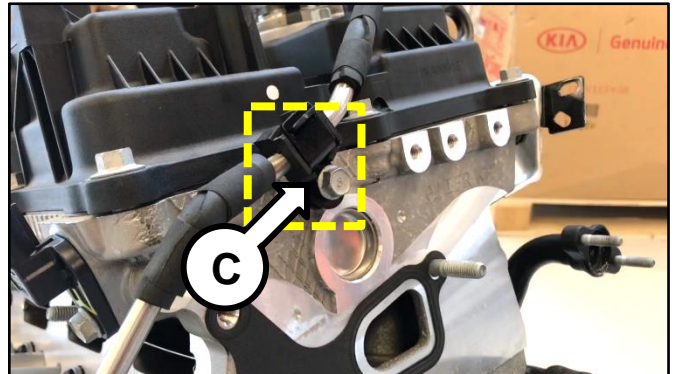
If the bracket and bolt are missing, order and install a new bracket and bolt.

2. Install the pipe retaining bracket and bolt (C) and torque to specifications.

Tightening torque (bracket bolt):
 5.8 – 8.7 lb.ft (7.8 – 11.8 N.m,
 0.8 – 1.2 kgf.m)
