GROUP ELE	MODEL 2014-2018MY Forte (YD, YDm)
NUMBER 159	DATE April 2019

TECHNICAL SERVICE BULLETIN

SUBJECT: STEERING WHEEL MOUNTED AUDIO
CONTROL MALFUNCTION

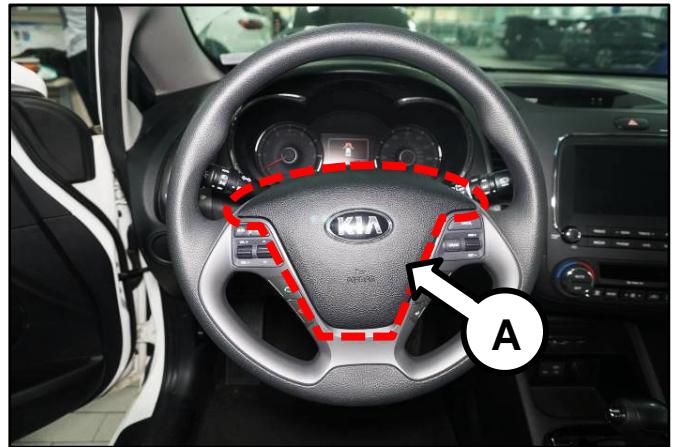
1. Retain or record the customer's radio presets using a Memory Saver.
2. Remove the Driver Airbag Module (A) by referring to steps 1 through 5 of the "Restraint → Airbag Module → Driver Airbag (DAB) Module and Clock Spring → Repair procedures" chapter in the applicable Shop Manual on KGIS.
