GROUP ELE	MODEL 2018MY Stinger (CK) 2018-2019MY Niro Plug-in (DE PHEV) with UVO 3.0
	NUMBER 162 (Rev 1, 04/24/2019)	DATE December 2018

**SUBJECT:** SERVICE ACTION: UVO 3.0 LOGIC IMPROVEMENT  
FOR BLACK SCREEN (SA366)

**This issue number is SA366.**

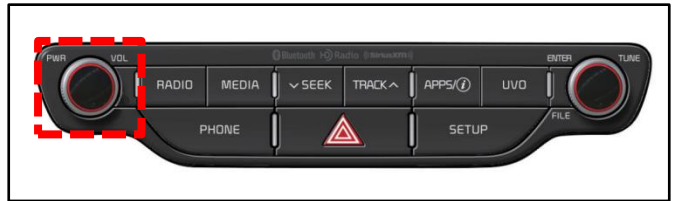
1. Start the vehicle and power on the UVO 3.0 head unit.

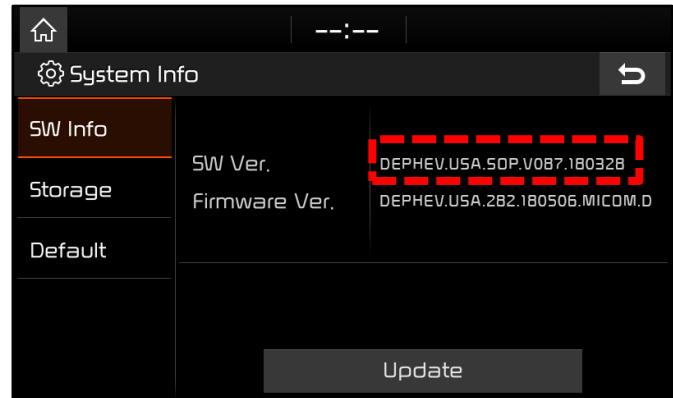
7. Check the software version and proceed to the Software Update Procedure on page 4 if the version matches the "Current Version" table below.

- If it matches the "New Version" table, no further action is required.
- If it does not match either table, open a Techline case [online](#).
