GROUP ELE	MODEL 2020MY Telluride (ON)
	NUMBER 178	DATE April 2019
TECHNICAL SERVICE BULLETIN		
SUBJECT: SERVICE ACTION: TELLURIDE (ON) HEADLAMP INSPECTION (SA380)

This issue number is SA380.

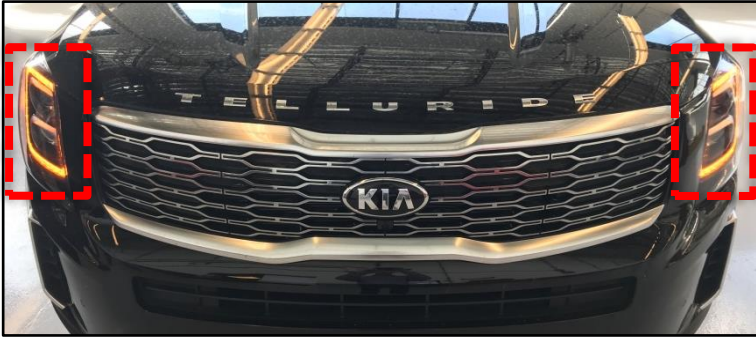
This bulletin provides information on certain 2020MY Telluride (ON) vehicles, produced from February 13, 2019 through March 30, 2019, which may exhibit intermittent or inoperative Daytime Running Lamp (DRL) at the headlamps due to an internal connection fault. Follow the procedure in this bulletin to inspect and, if necessary, replace the headlamp(s). Kia is requesting the completion of this Service Action on all affected vehicles in dealer stock only, prior to delivery. Before conducting the procedure, verify that the vehicle is included in the list of affected VINs.
