GROUP <b>CHA</b>	MODEL <b>2020MY Telluride (ON)</b>
NUMBER <b>097</b>	DATE <b>April 2019</b>

## TECHNICAL SERVICE BULLETIN

**SUBJECT: SERVICE ACTION: INTERMEDIATE STEERING SHAFT  
UNIVERSAL JOINT INSPECTION (SA383)**

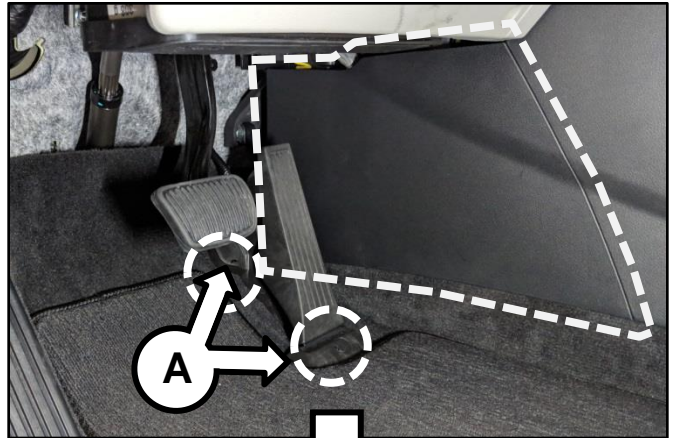
- 1a. Remove the left side cover from the floor console by referring to the “**Body (Interior and Exterior) → Floor Console → Floor Console Assembly → Repair procedures, Step 4**” chapter in the applicable Workshop Manual on KGIS.

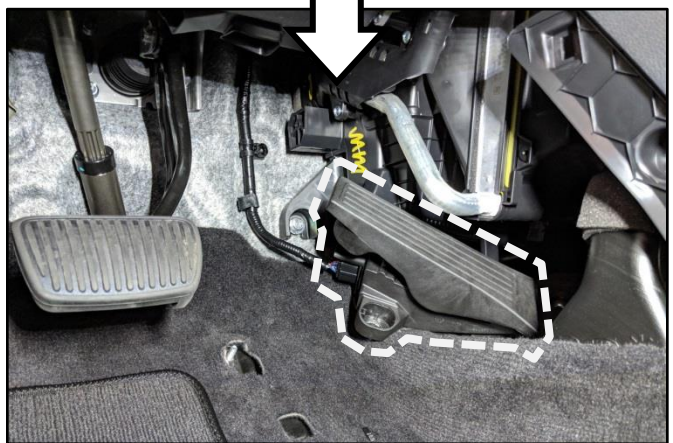
- 1b. Remove the two (2) retaining bolts (A) and remove the Accelerator Position Sensor (APS) Pedal.

**Do Not** disconnect the rear APS connector from the rear of the pedal. Move the pedal assembly to the side as shown.

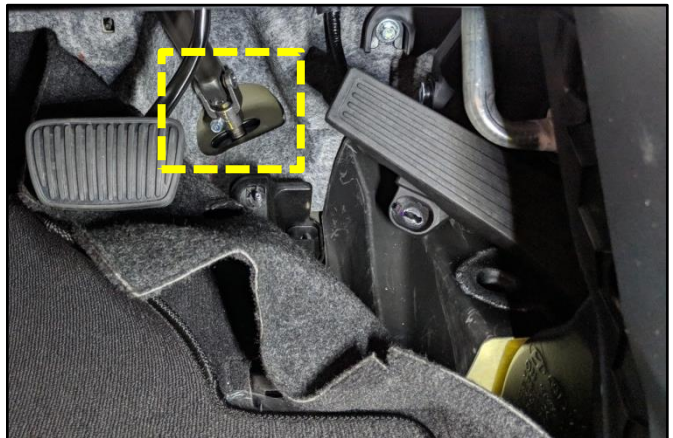
2. Roll the carpet back to expose the intermediate steering shaft universal joint.

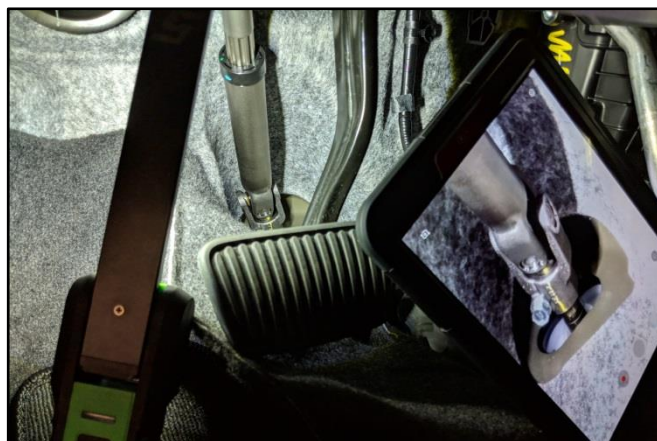
5. **Requirement:** Using the Warranty Claim Attachment feature on KVID, take one (1) clear KVID photo showing the ruler and dimension less than 20 mm (0.78 inch) and complete the Intermediate Steering Shaft Universal Joint Inspection form outlined on Page 5.

6. If the intermediate steering shaft universal "joint bottom to floor panel" measurement is within specification and witness mark is present, or witness mark was missing and universal joint bolt was torqued to specification, then install all removed parts in the reverse order of removal. The action is complete.
