| REFERENCE: | Nova Bus Manuals |
| RS N°: | MQR 7621-1331 |

| SUBJECT: | Throttle pedal sensor (TPS) cable replacement | | | |
| JUSTIFICATION: | Cummins code 1242 for throttle pedal sensor circuit | | | |

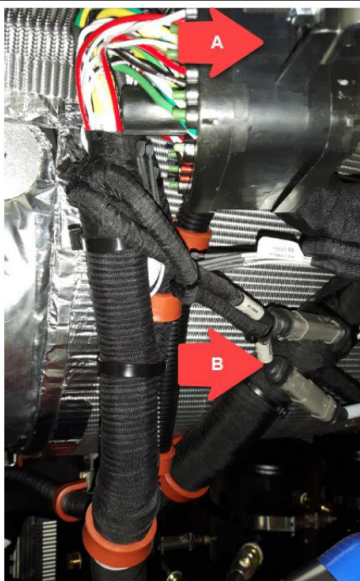
**DCP-504300****FUEL PEDAL – EMI interference close to Alternator****DCP-504300**  
Operation: C0095D

| Instructions Spéciales/ Special Instruction | | |
|---|---|---|
| | Déplacer | <p>Les x2 connecteurs (MT-X9564E) sont situés trop près de l'alternateur, ce qui altère le signal d'accélération de la pédale à carburant (EMI). Déplacer les connecteurs de la localisation A à la localisation B.</p> <p>The 2 connectors (MT-X9564E) are located too close to the alternator and create EMI to the accelerator pedal signal. Need to move connector from location A to location B (see picture)</p> |

- If DCP-504300 was not properly implemented, relocate the two TPS cable connectors further away from the alternator by following the instructions provided.
