REFERENCE:	Nova Bus Manuals
SECTION:	16: Electrical system
RS N°:	MQR 7621-1331
EFFECTIVE IN PROD.:	LB45 (2018AL)

SUBJECT:	Throttle pedal sensors (TPS) cable replacement			
JUSTIFICATION:	Cummins code 1242 for throttle pedal sensor circuit			
LEVEL	DESCRIPTION	DIRECT CHARGES		TIME
		LABOUR	MATERIAL	
1	Install the throttle pedal sensor bypass cable.	Client	Client	2.75 h
2	Install the throttle pedal sensor front to back cable.	Client	Client	16 h

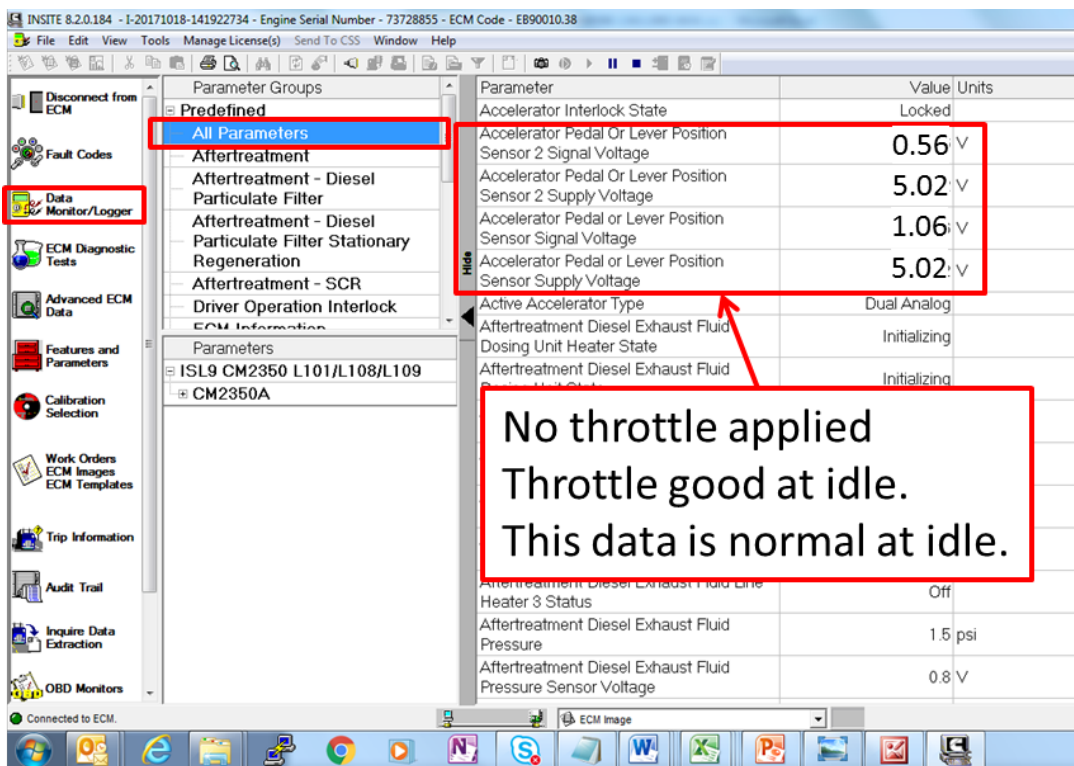
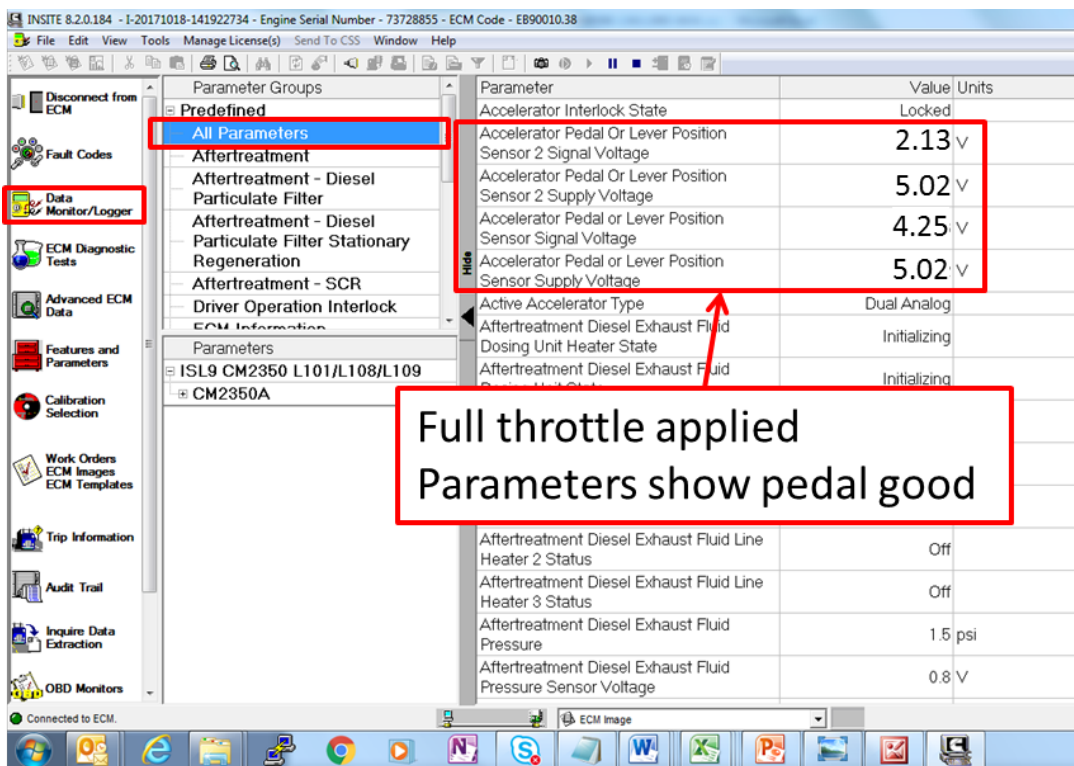
Figure A3.2. Example of INSITE Normal (PASS) Readings at Idle and Full Throttle Positions

- **Good APS 1 (PASS condition):**
 - Reading is 4.25 V and steady when throttle pedal fully depressed.
- **Bad APS 1 (FAIL condition):**
 - Reading is unstable with throttle pedal being held steady.
- **Bad APS 1 (FAIL condition):**
 - Reading is around 4.19 V (low).
- **Good APS 2 (PASS condition):**
 - Reading is 2.13 V and steady when throttle pedal fully depressed.
- **Bad APS 2 (FAIL condition):**
 - Reading is unstable with throttle pedal being held steady.
- **Bad APS 2 (FAIL condition):**
 - Signal 2 is about 2.03 V (low).
