# Service Action

## Code: 19N8

<b>Subject</b>	<b>After-Run Coolant Pump</b>
<b>Release Date</b>	April 16, 2019
<b>Affected Vehicles</b>	<b>U.S.A.: Certain 2012-2017 MY Audi vehicles with a 2.0L TFSI gasoline engine</b> <b>CANADA: Certain 2013-2017 MY Audi vehicles with a 2.0L TFSI gasoline engine</b> <i>Check Campaigns/Actions screen in Elsa on the day of repair to verify that a VIN qualifies for repair under this action. Elsa is the <u>only</u> valid campaign inquiry &amp; verification source.</i> <ul style="list-style-type: none"><li>✓ Campaign status must show "open."</li><li>✓ If Elsa shows other open action(s), inform your customer so that the work can also be completed at the same time the vehicle is in the workshop for this campaign.</li></ul>
<b>Problem Description</b>	Power to the electric (after-run) coolant pump was disconnected under Safety Recall 19N4.
<b>Corrective Action</b>	Install a new electric (after-run) coolant pump and update ECM software.

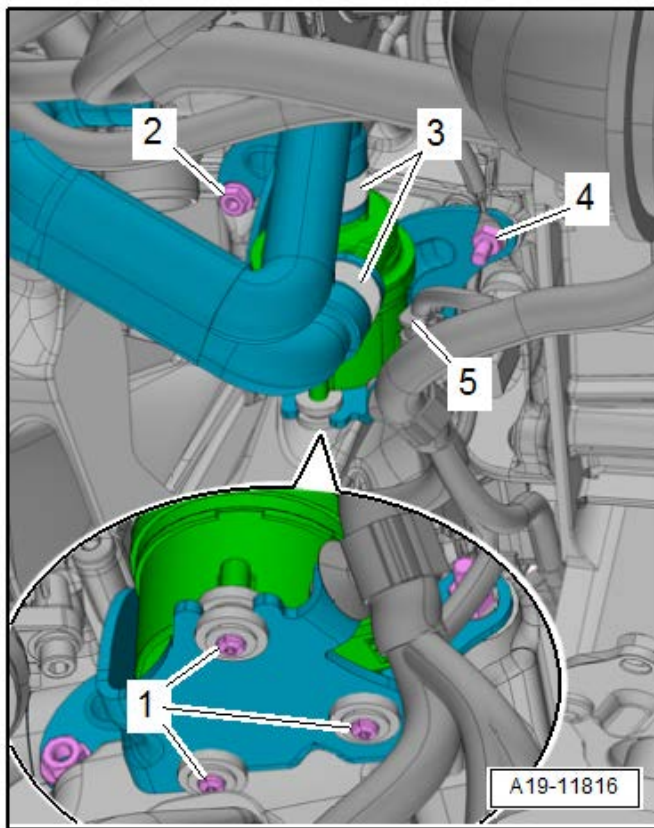
- Check the wiring connector AND the coolant pump connector housing for the following:
  - Signs of overheating
  - Pin corrosion
  - Coolant intrusion
- The wiring connector housing, pins and seals must be replaced if the connector housing is found damaged at the time of repair.

Qty.	Part Number	Part Description
1	000.979.940	Butt connector for 0.5 mm wire
2	000.979.941	Butt connector for 1.0 mm wire
1	000.979.034.E	0.5 mm wire
1	000.979.159.E	1.0 mm wire
3	3C0.972.741	Wire seal
1	4H0.973.703	Connector housing

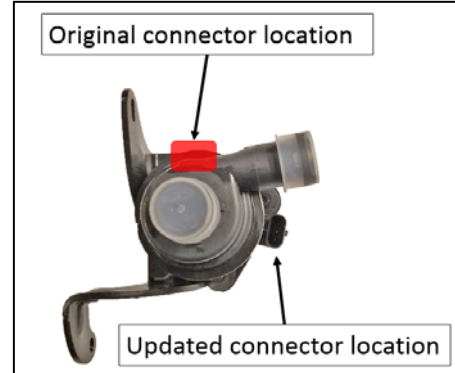
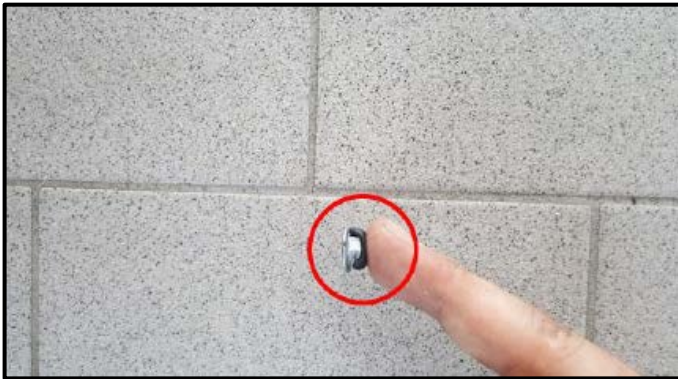
Due to the new location of the connector on the new pumps, the after-run coolant pump wiring harness <arrow> may have to be routed so it does not come into contact with the pump coolant hose.

When installing nut <2>, a swivel socket may not clear the coolant hose fitting.
