GLOBAL SAFETY FIELD INVESTIGATIONS
DCS4994
URGENT - DISTRIBUTE IMMEDIATELY

Subject: N192208640 - Service Update
Engine Runs Rough, Stall, No Restart Due To Damaged Ground
Terminal

Models: 2019 Chevrolet Blazer

N192208640 Engine Runs Rough, Stall, No Restart Due To Damaged Ground Terminal

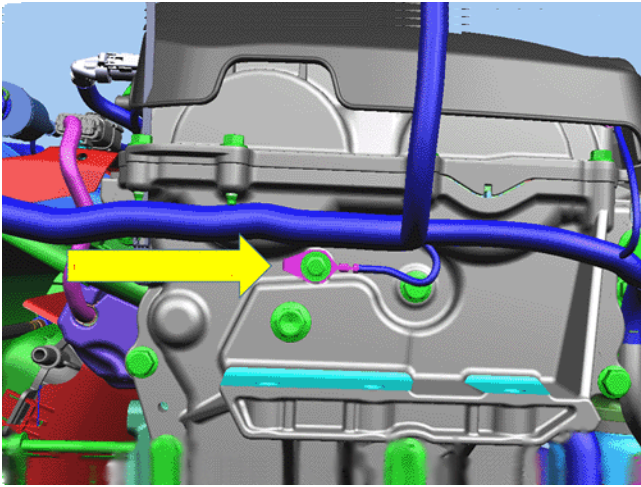
5271486

- If the ground ring tab is rotated in a different direction, the wire connection on the ring is bent or there appears to be a strain on the wire, proceed to step number 3.
3. Remove the air cleaner assembly. Refer to *Air Cleaner Assembly Replacement* in SI.
 4. Unbolt the G113 ground terminal ring from the engine.
 5. Unwrap the harness tape from the G113 branch.
