Service Bulletin

Bulletin No.: 17-NA-166

Date: April, 2019

Subject: Rough Idle in Drive

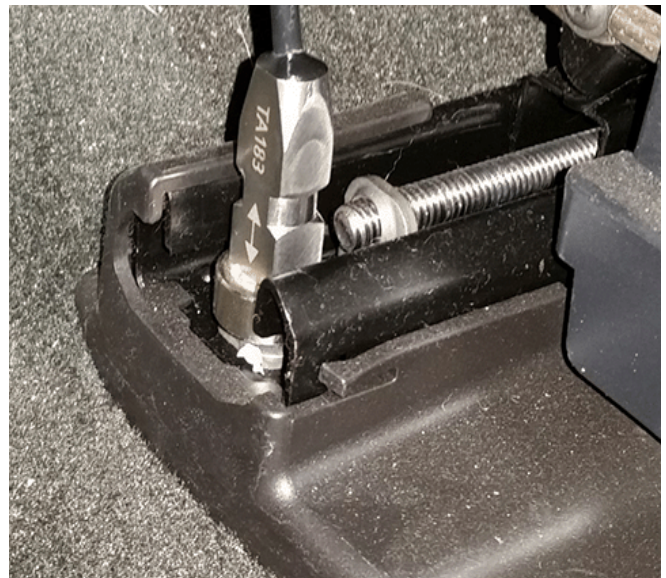
4532456

Note: If using a single-axis pico sensor, mount and test both vertically and horizontally – E1.5 rough idle vibration will usually be horizontal / lateral at the seat track.

(TA183 single axis pico sensor shown / TA143 is tri-axis sensor)

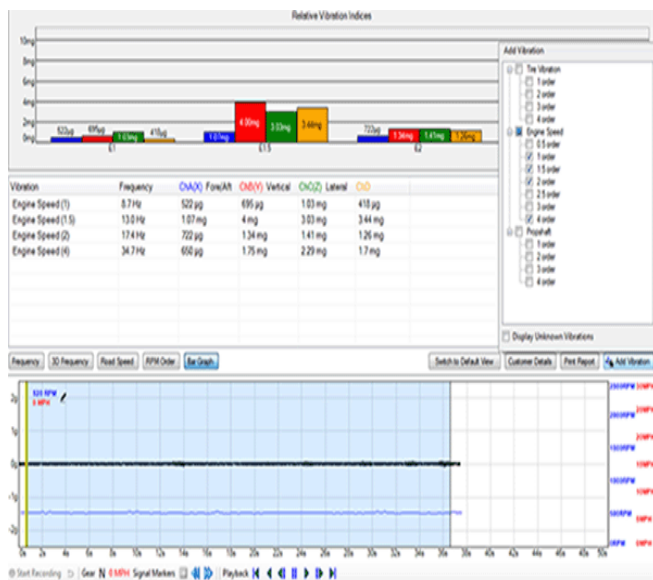
4534309

Add E1.5 to the displayed data and turn Off T and P related data (under Add Vibration in Pico) since issue occurs with vehicle stationary.

Note: Amplitude (mg) readings from a single-axis pico sensor will be approximately 10% lower than with a tri-axis sensor. For example a reading of 4 mg using a tri-axis sensor, would likely measure as about 3.6 mg on a single-axis sensor.

If the disturbance frequency measures at the seat track as E1.5 with amplitude of approximately 2 mg or higher using a tri-axis sensor, continue with steps in this bulletin to reduce the amplitude (mg) of the disturbance, then exercise the vehicle and re-measure using pico to determine level of improvement.

If the E1.5 disturbance measures approximately 2 mg or lower using the Pico tri-axis sensor as indicated – the vehicle is considered acceptable.

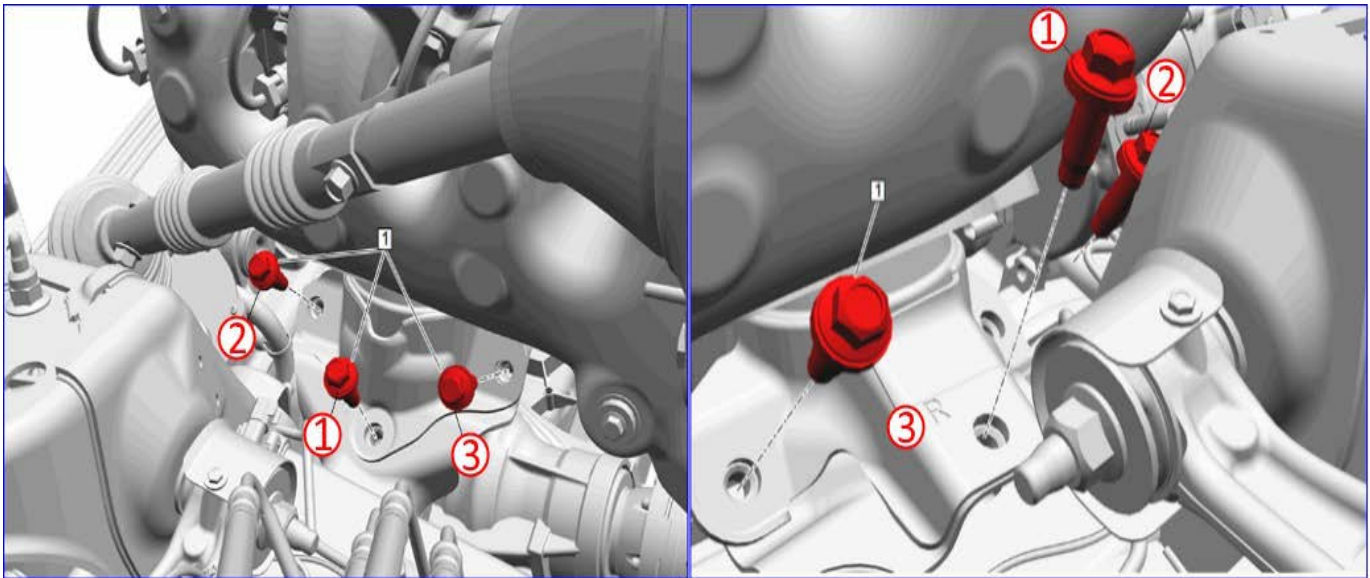
5318277

Note: Idle vibration caused by ground-out within an engine mount may be able to be turned off/on with a single bolt location. Shimming that bolt location may greatly reduce the vibration. In some cases, a combination of bolt location shimming may be needed.

1. With the aid of an assistant, run vehicle in stall with the parking brake set and base brake applied, in Drive, monitoring E1.5 on Pico at inboard seat track, with idle vibration active, perform the following:

Important: Do Not use Impact wrenches when tightening the engine mount to frame bolts, or damage to threads in the frame may result.

2. Beginning with RH side, loosen the engine mount to frame bolts one at a time a few turns to release clamp load beginning with rear bolt at position 6, front bolt at position 5 and the middle bolt at position 4.
 - ⇒ Verify if idle vibration was significantly reduced or eliminated when the bolts were loosened.
3. Torque bolts to specifications in order and validate if the vibration returns.
4. Repeat the process on the LH mount starting at the rear bolt at position 3, front bolt at position 2 and the middle bolt at position 1.
 - If idle vibration **Does Not** return when the RH or LH engine mount bolts are re-torqued to specifications, no further work is required.
 - If idle vibration **Does** return, proceed with procedure.

5. Beginning with RH side, loosen the engine mount (1) to frame bolts one at a time a few turns to release clamp load.
6. Remove the position 5 and 6 bolts (2),
7. Utilizing a jack with a block of wood, carefully raise the engine.
