Service Bulletin

Bulletin No.: 19-NA-047

Subject: Radio Software Version V803 Over-the-Air Update

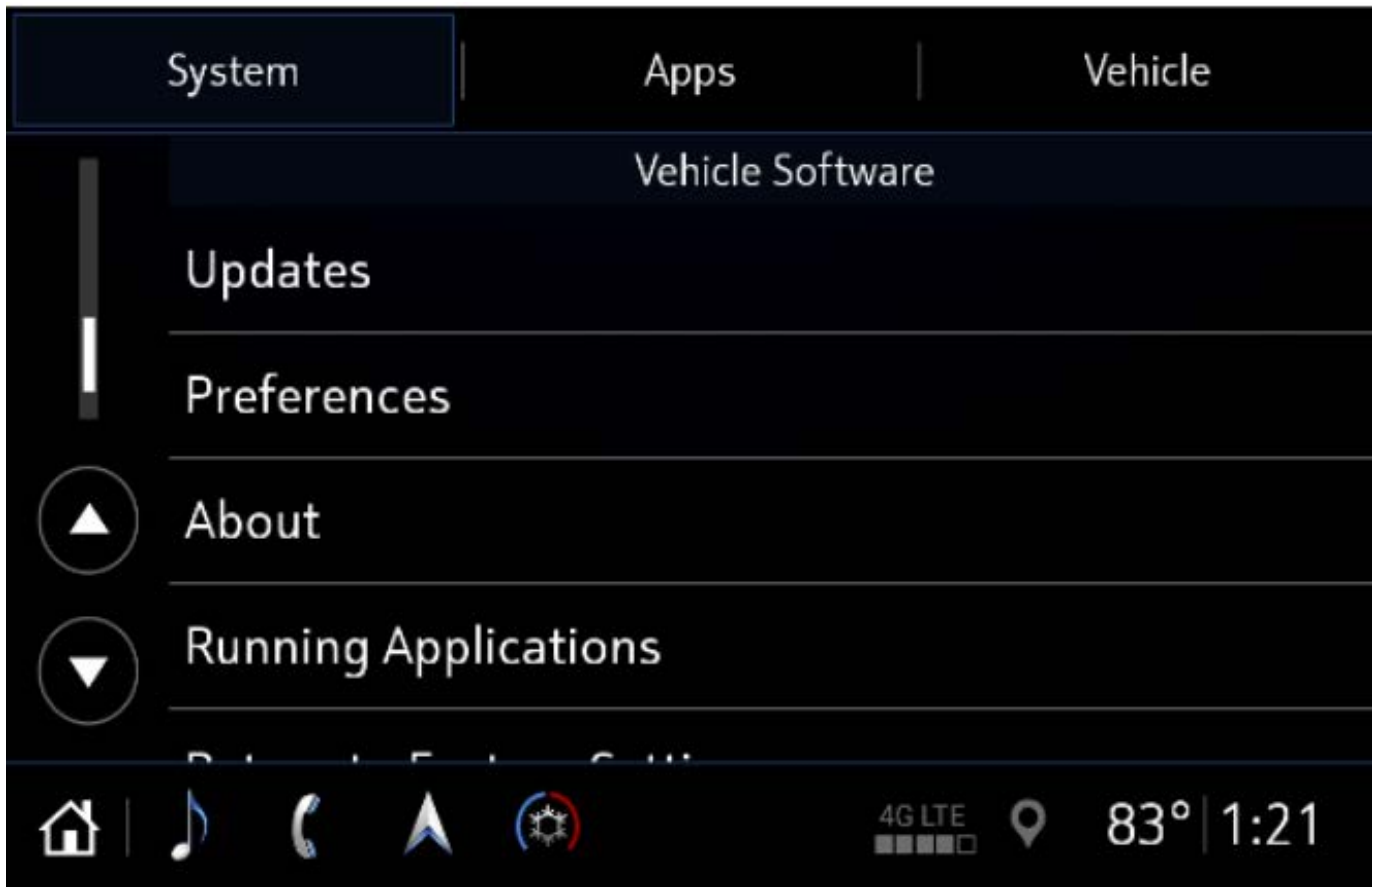
5258719

The process used for this update is dependent on the status of the software on the module and if the module already has a remote install package downloaded. To verify if an update package is already on the vehicle, open “Settings” and then scroll to “Updates” on the radio screen. If an update is shown under the “Updates” screen, proceed to the **Update Procedure Using Remote Vehicle Update** section of this document.

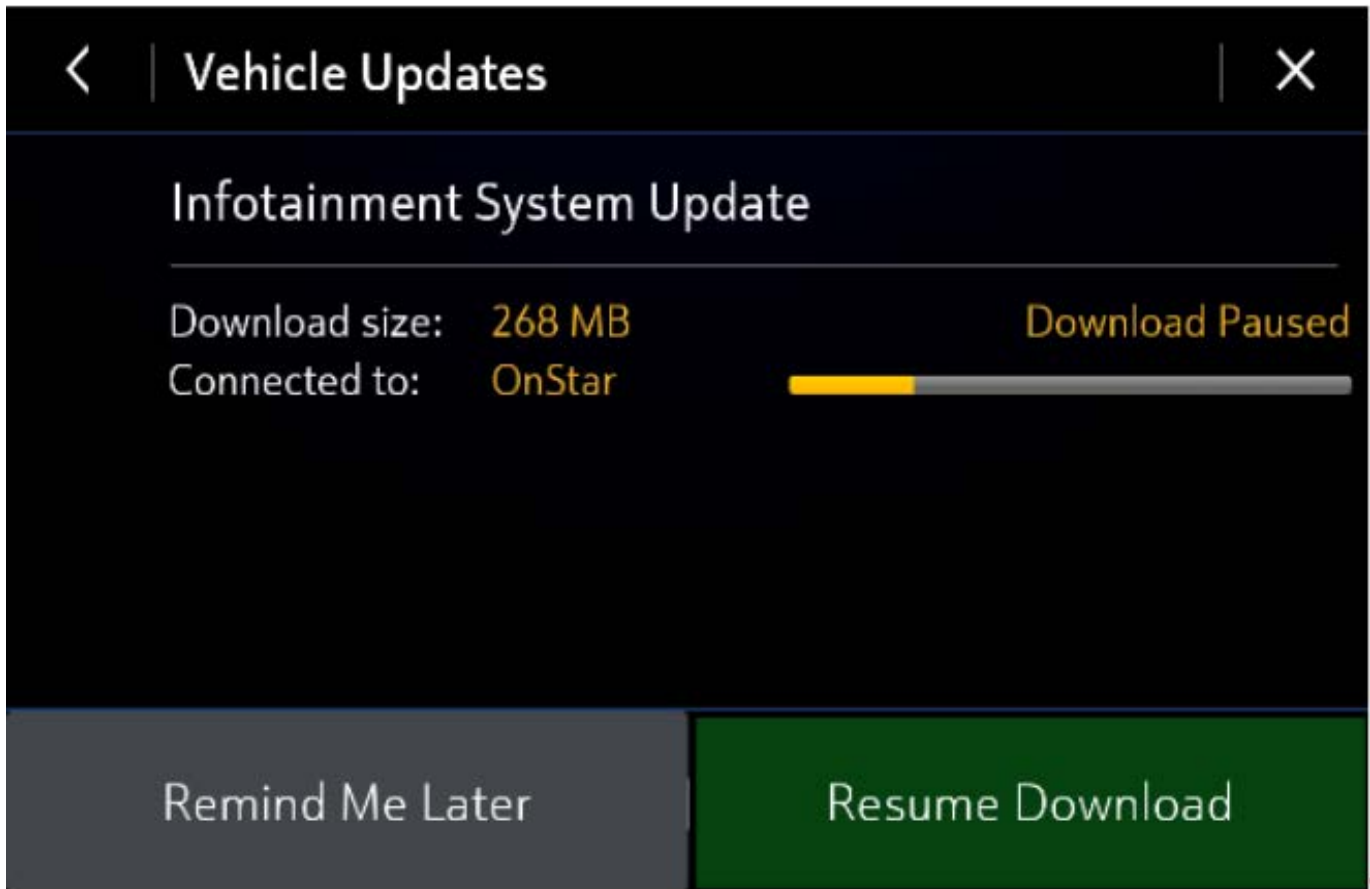
5258724

If no update is shown (see “No Updates Available” image in next section), go to the “About” screen and verify the build number (i.e., L206, V507, V509 etc.). If the build number is less than V803, proceed with the software update following the **Update Procedure Using TIS2WEB (USB Download)** section of this document.

Caution: If Vehicle Update screen shows “Infotainment System Update” (such as the screen above) do not use TIS2WEB or insert a USB stick. Use of the USB stick when the Remote Update has already been downloaded, installed, or paused during installation could result in program failures or module lockup condition. The update should be completed using the Remote Vehicle Update procedure, following prompts on the infotainment screen. Refer to Update Procedure Using Remote Vehicle Update after reading the remaining information in this section if the Remote Update has already been downloaded to the radio.

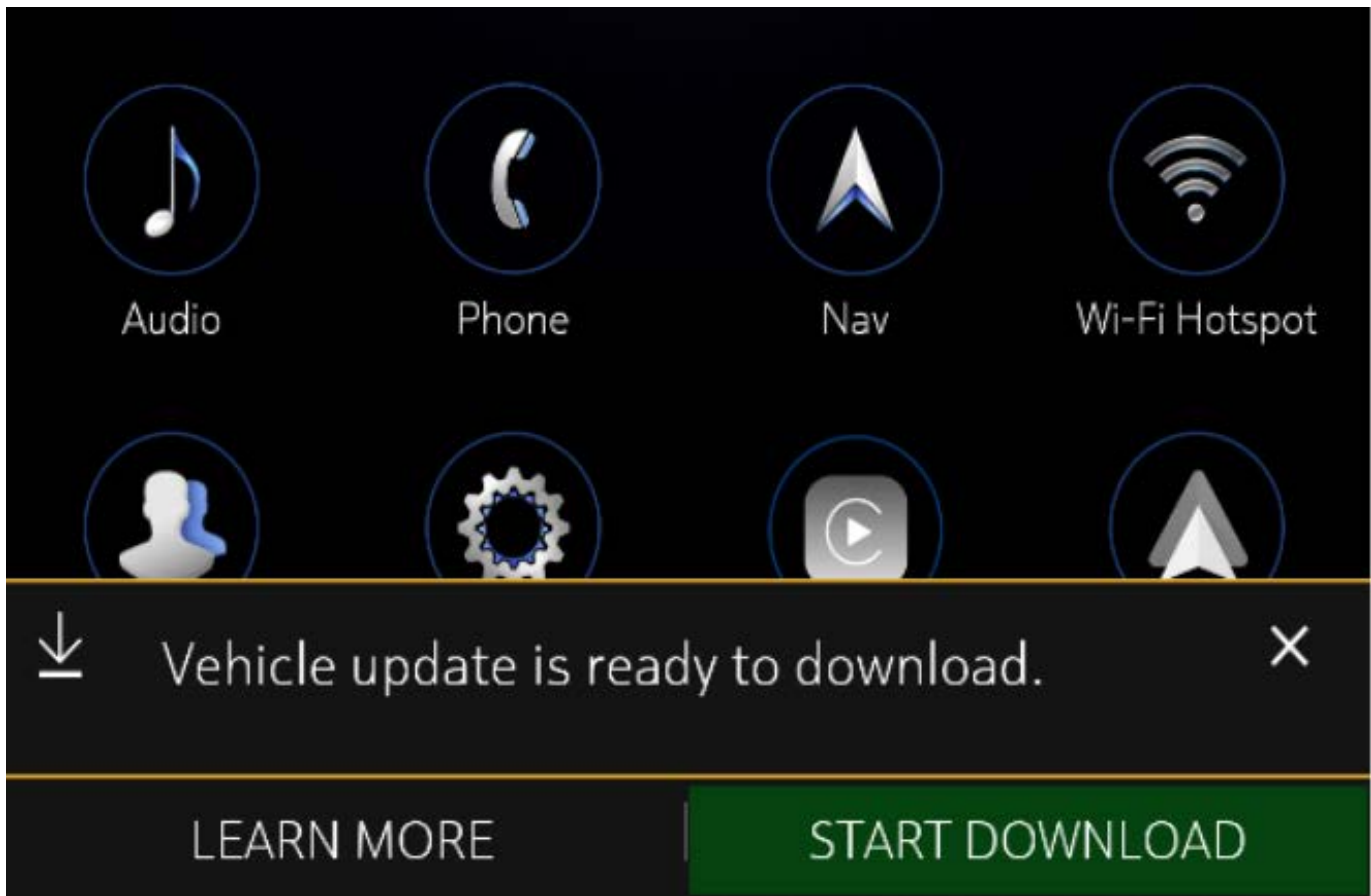
5258732

1. If a remote package is on the system, you may see the below pop up.
 - If the remote vehicle update has not been downloaded, select “Start Download”, wait for the download to complete and then follow the prompts to complete installation.

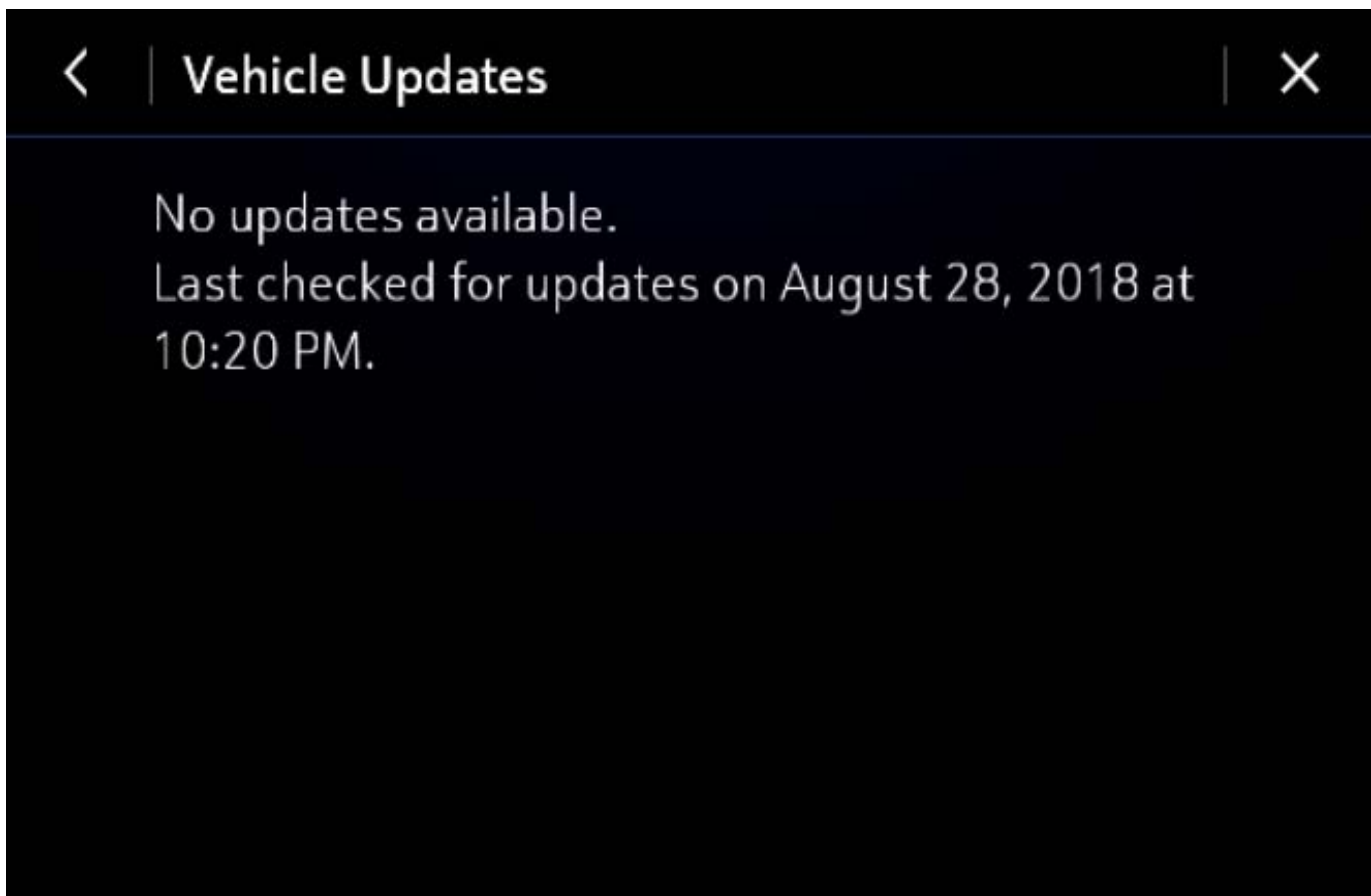
5258736

2. If no "Start Download" or "Install Now" pop up is displayed, navigate to "Settings" -> "Updates." If there is a remote package on the system, it will display "Install Now" Or "Start Download." If the screen below is shown, then there is no remote update package on the system. Navigate to Settings -> About to verify the software version. If the build number is not V803 or greater, update via USB.

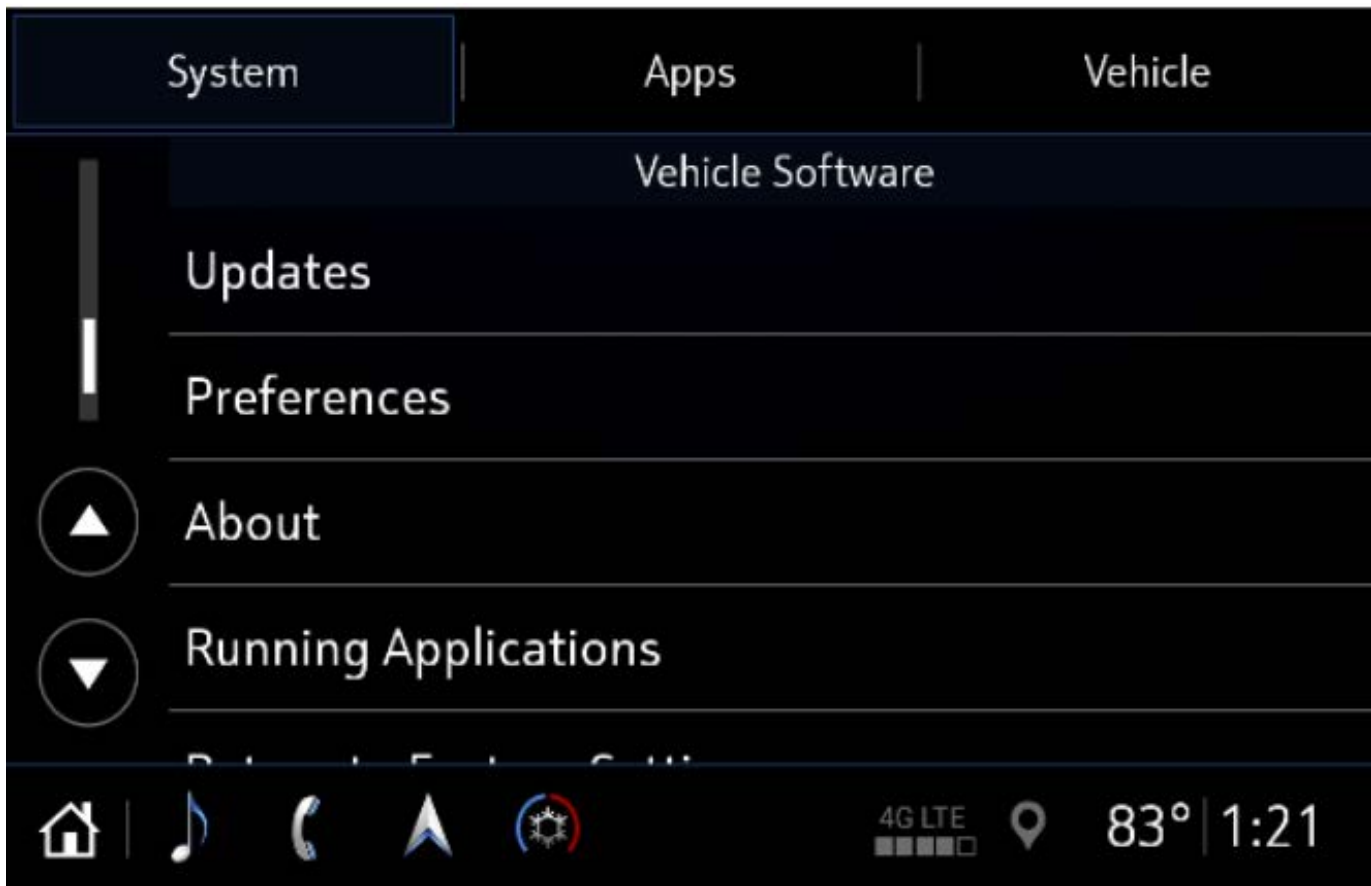
1. Start SPS, select Radio – USB File Transfer and follow the on-screen instructions.
2. Record the SPS Warranty Claim Code on the job card.

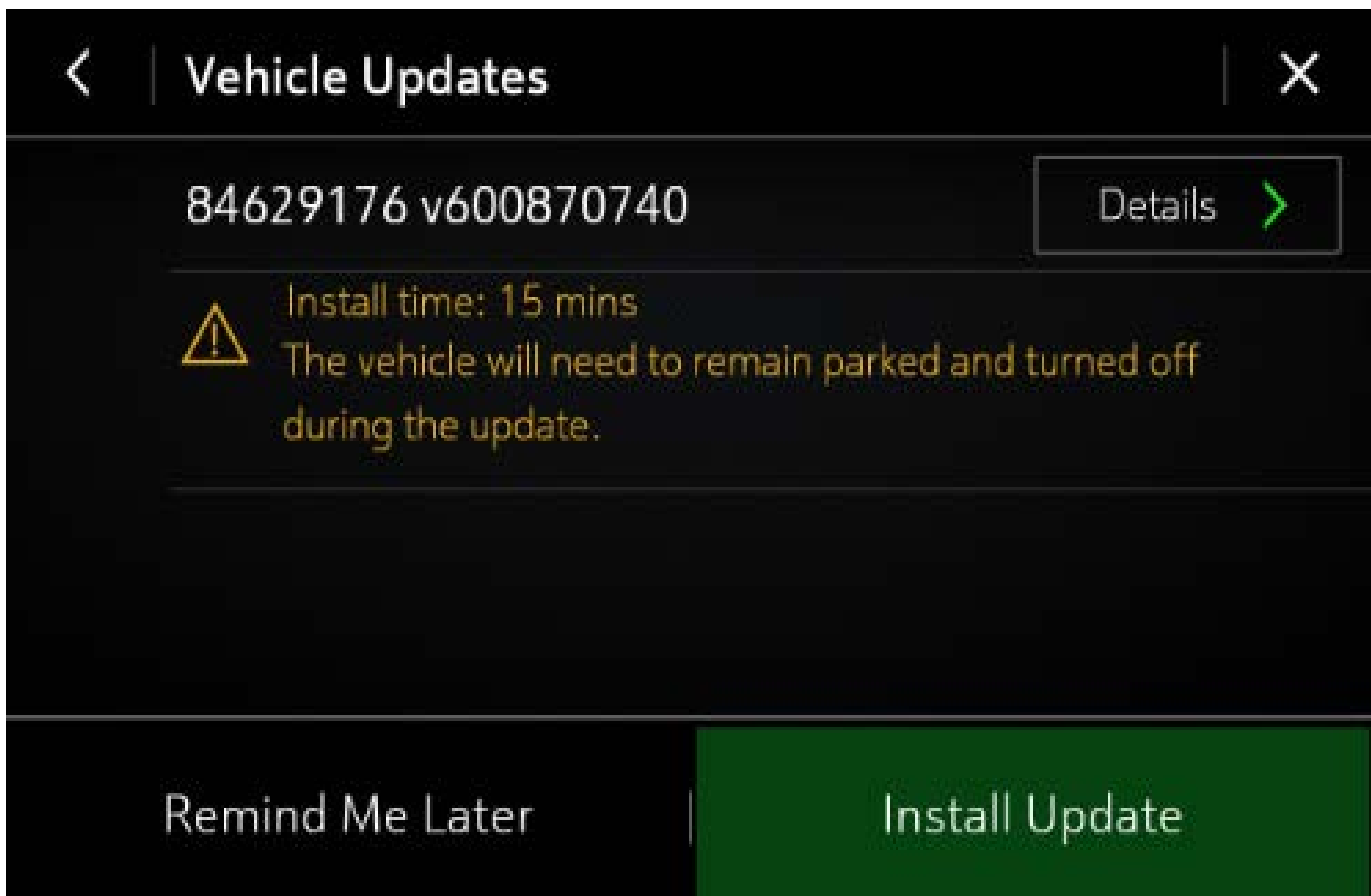
5258740

3. Insert the USB into the vehicle while in Park. On the radio screen, select “Settings” —> “Updates” or select “Learn More” on pop up after USB insertion.
4. Confirm the part number with image below.
5. Follow on screen prompts to complete the update.
