**PRODUCT CAMPAIGN BULLETIN**

**APPLICABILITY:** 2019MY Forester and Crosstrek Vehicles      **NUMBER:** WUC-88R  
**SUBJECT:** Power Steering Gear Box Inspect/Replacement      **DATE:** 02/12/19  
**REVISED:** 04/08/19  
**NHTSA ID:** 19V-065

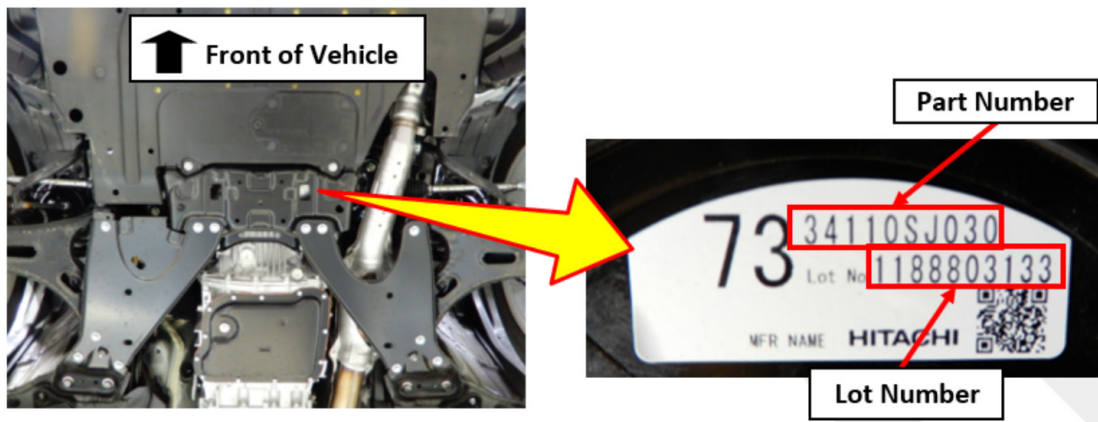
- 1) After confirming applicability, raise the vehicle on a lift.
- 2) The EPS Label and Lot Number are accessible through a hole in the crossmember support as shown.

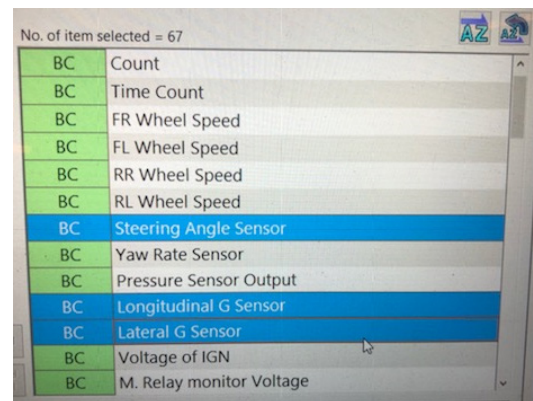
- 10) Check that the output values for the longitudinal G sensor and lateral G sensor are  $-2 \text{ — } 2 \text{ m/s}^2$ . **If the output value is different from the standard value, check the installing condition of the hydraulic unit assembly VDC and the bracket COMPL hydraulic unit VDC.**

- 11) On [Select Function] screen, select [Work Support].
- 12) From the work support item list, select [VSC(VDC) Centering Mode], and perform the setting according to the procedure displayed on the Subaru Select Monitor screen.
