# Service Bulletin

Bulletin No.: 19-NA-073

**Subject:** Difficult to Shift into Gear, Intermittent Gear Pop Out and/or Mushy Shifts (No Grind)

Brand:	Model:	Model Year:		VIN:		Engine:	Transmission:
		from	to	from	to		
Chevrolet	Corvette	2014	2019			All	Equipped with 7 Speed Manual Transmission (RPO MEL, MEP, MEK)

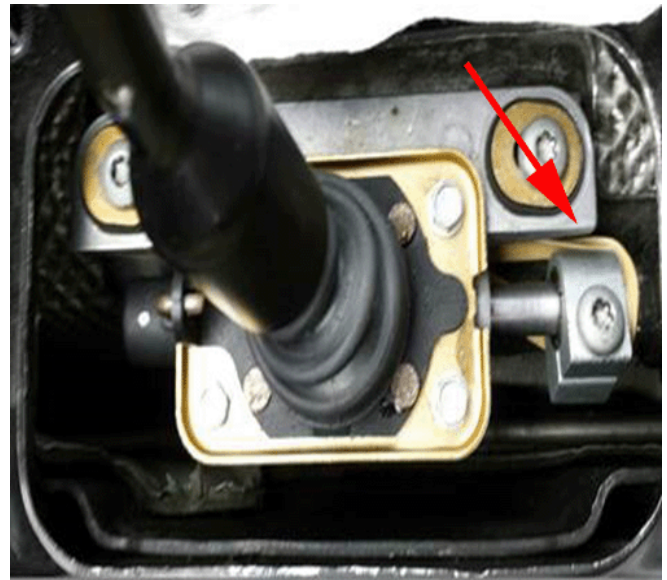
4329176

**Note:** There may be some variation on how and where the rubber band is placed. The above picture shows one possible location.

3. Remove the transmission control lower closeout boot retaining nuts (1).
4. Remove the transmission lower closeout boot (2) assembly.

5. Before performing the shifter adjustment, make sure that the rubber band used to retain the shifter link during assembly is removed.
