Title: LT Fuller Advantage Series Transmission Power and Ground

Applies To: LT w/ A26 & X15

This document will provide the user with Fuller Advantage Series (FAS) Automated Transmission power and ground circuit information.

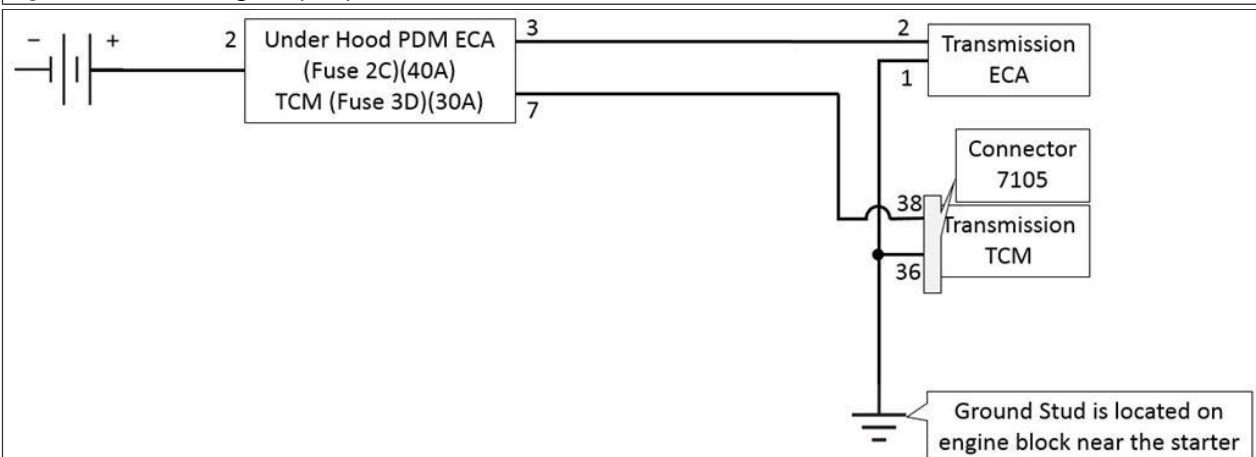
**Figure #1: Circuit Diagram (A26)**

1. While performing Eaton diagnostic steps be sure to inspect the power and ground connections at the Underhood PDM and the Ground Stud located by the engine starter.
  2. Ensure the connections are clean (free of corrosion) and tight, Ground Stud Torque 43 N-m (31.7 ft-lb).
-

1. Clean and tighten any loose connections.
  2. Clearly document in RO, with Road Ranger, and or Navistar tech service if loose connection was found.
  3. Clear DTC's in all modules.
-
