PIP5412A Whine Howl Noise From Under Center Of Vehicle

PIP5412B Supersedes PIP5412A on 5/23/2019 please discard all previous versions.

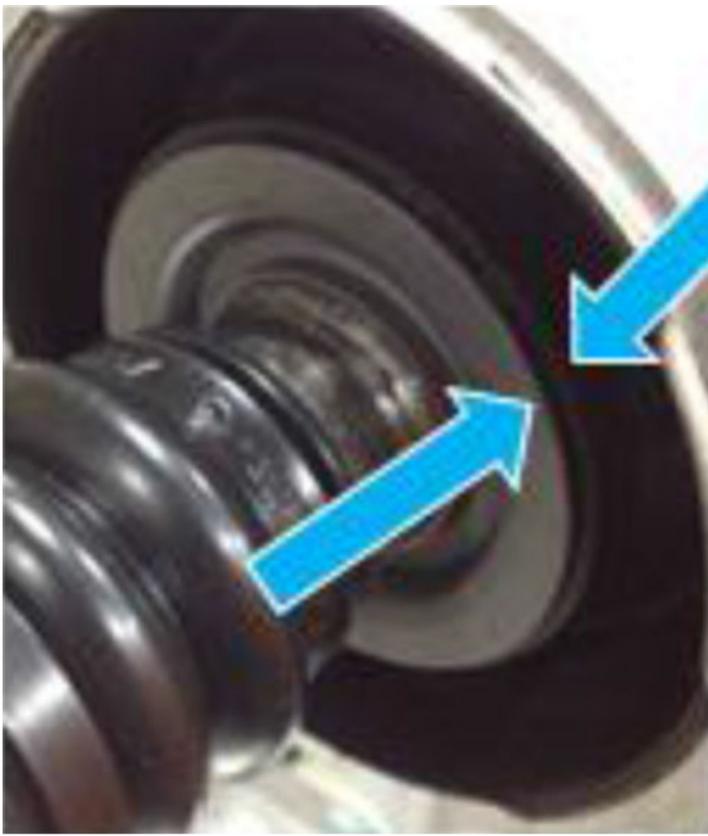
See photos below. Picture 5, make sure bearing mount is in the groove on both sides and centered in the bolt holes on the left and right.

Ensure that when the replacement shaft is installed the bearing support is installed in such a manner to not load the bearing in the rubber mount.

Inspect the replacement drive shaft for clearance between the slinger and rubber mount. Clearance should be between .7 and 1 mm (.027-.040 in).
