Replace Huck BOM Fastener on Front Seats

Classification Repair Bulletin **Section/Group** 13 - Seats **Country/Region** All

Year 2015-2018 **Model** Model S, Model X **Version** All

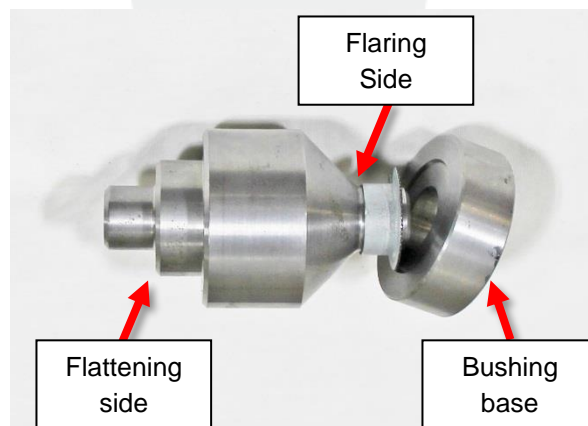
Figure 7

NOTE: The main parts of the flare tool (Figure 7) are:

- c. Remove the flare tool from the Huck BOM Replacement kit.
