SERVICE BULLETIN

| Classification: BT09-052g | Reference: NTB09-081g | Date: May 15, 2019 |

WINDSHIELD CRACKING

APPLIED VEHICLES: All Nissan models

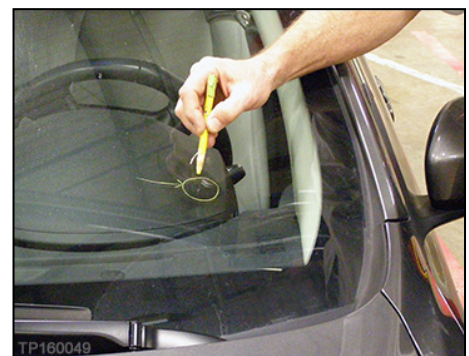
Prior to removal, dealers must take at least two digital photographs of the damaged area. Dealers are required to mark glass and other components returned that have "visible issues" using masking tape or appropriate means (grease pen, etc.) to identify and highlight the area damaged.

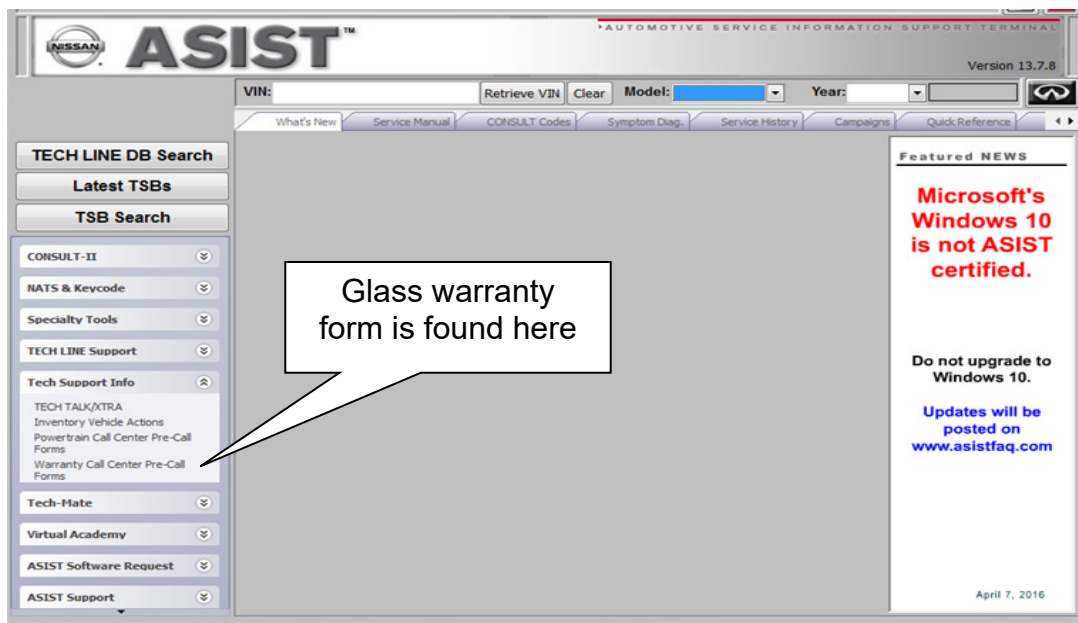
- Dealers are required to take at least two digital photographs that clearly identify the alleged glass defect prior to removing the glass from the vehicle.
- Digital photographs must be kept in dealer records.
- Dealers are required to mark glass and other components returned that have “visible issues” using masking tape or appropriate means (grease pen, etc.) to identify and highlight the area damaged.
- The new glass warranty form must be completed and digital photograph files attached through ASIST for:
 1. Over DCAL Warranty Call Center pre-authorization
 2. Glass Part Return requests
- **The claim will be subject to a claim debit if the part is not marked properly and/or missing the required digital photographs (via ASIST) to support identification of a warrantable defect.**
