TECHNICAL INFORMATION

| Bulletin # | Date | Page |
|---|---|---|
| MAS001850 | 06/05/2019 | 1/11 |

MODELLI: M161 Levante

OGGETTO: Diagnostic guide for sealing the body due water infiltration.

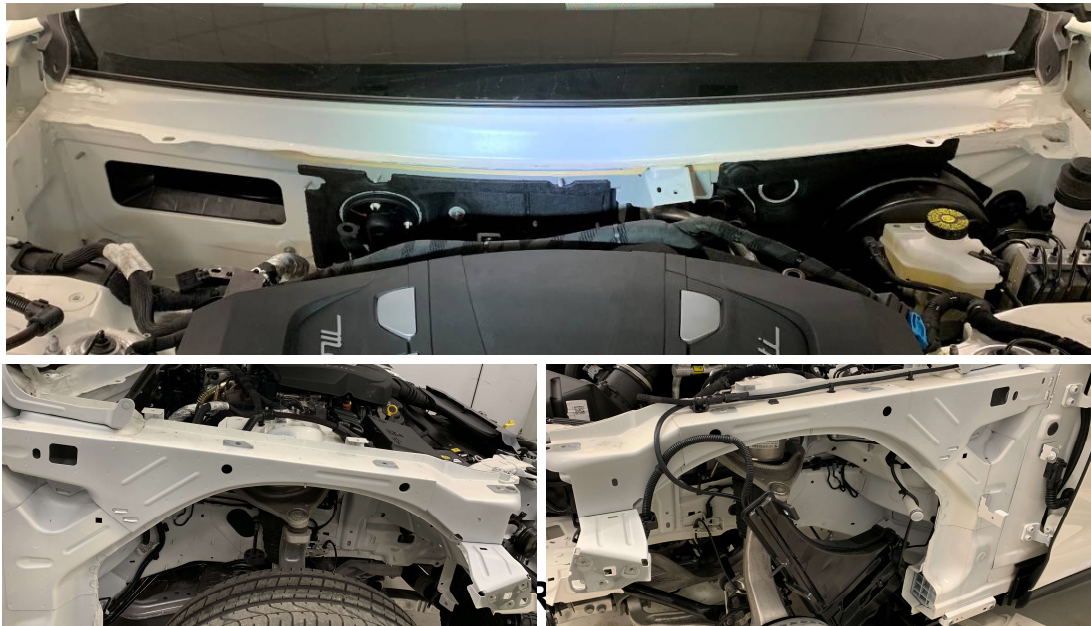
Once the following components have been removed, as shown in the following images, all areas to be sealed will be accessible.
