Maserati Technical Bulletin

Date: May 30, 2019
Bulletin No.: MAS001885 – MTB 19-10 –
Sedan_Levante Coolant Crossover Pipe
Service Campaign: 384
Supersedes: n/a
Section: Engine, cooling system, pipes

SERVICE CAMPAIGN # 384

SUBJECT: Coolant Crossover Pipe

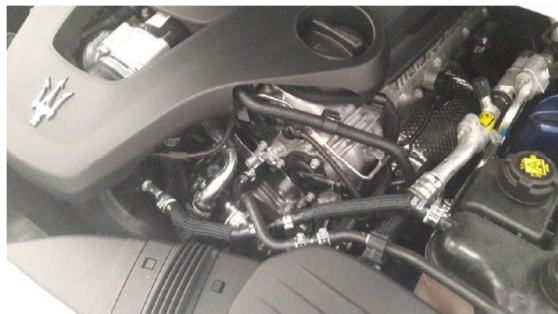
Fig.1

Maserati Quattroporte, Ghibli and Levante vehicles with V6 engines (Fig.1), are involved in a Service Campaign to check and if necessary, replace the Cooling system crossover pipe (#17 in Fig.2) due to a possible leak.

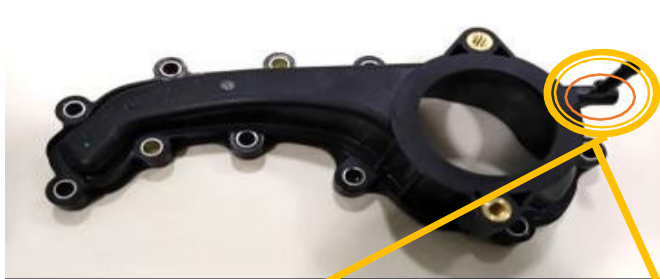
Ultra-Sonic weld Cap

MASERATI has been informed that some engines had a coolant crossover pipe that could lead to a coolant leak from a plug that is glued in place rather than ultra-sonic welded in place as shown below.

The glued cap will have traces of glue (see above) and must be replaced with a crossover pipe that has an "Ultra-sonic welded cap. (no traces of glue)
