**JOB AID
FOR
SPECIAL SERVICE CAMPAIGN K0B
MILLIMETER WAVE RADAR SENSOR**

**CERTAIN:
2018 – 2019 TACOMA
2018 – 2019 TUNDRA**

VEHICLES WITH MODIFICATIONS

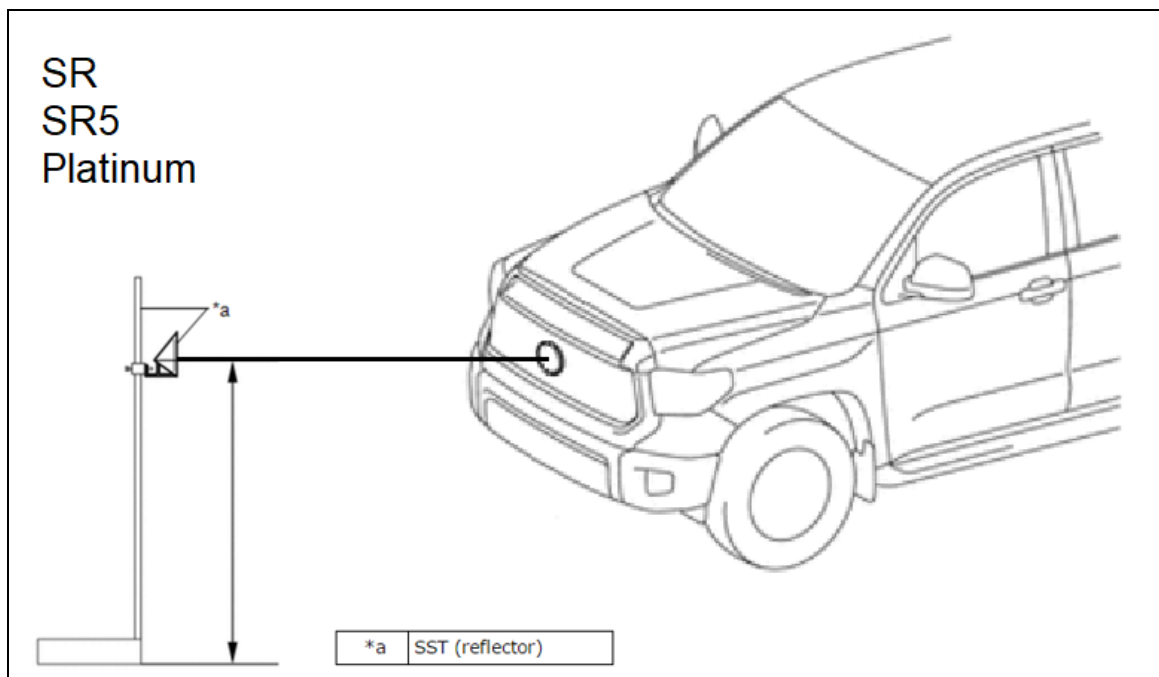
[CRUISE CONTROL: MILLIMETER WAVE RADAR SENSOR: ADJUSTMENT](#)

Because the modifications on this vehicle have changed the height of the MWRS from its original condition, it will be necessary to adjust the SST reflector height to match the height of the MWRS. When following the MWRS Adjustment procedure in the Repair Manual, change the height of the SST reflector to match the center of the MWRS in the grille.

- Adjust the height of the SST reflector to the center of the MWRS in the grille.
- Follow the Repair Manual procedure to properly calibrate the MWRS.

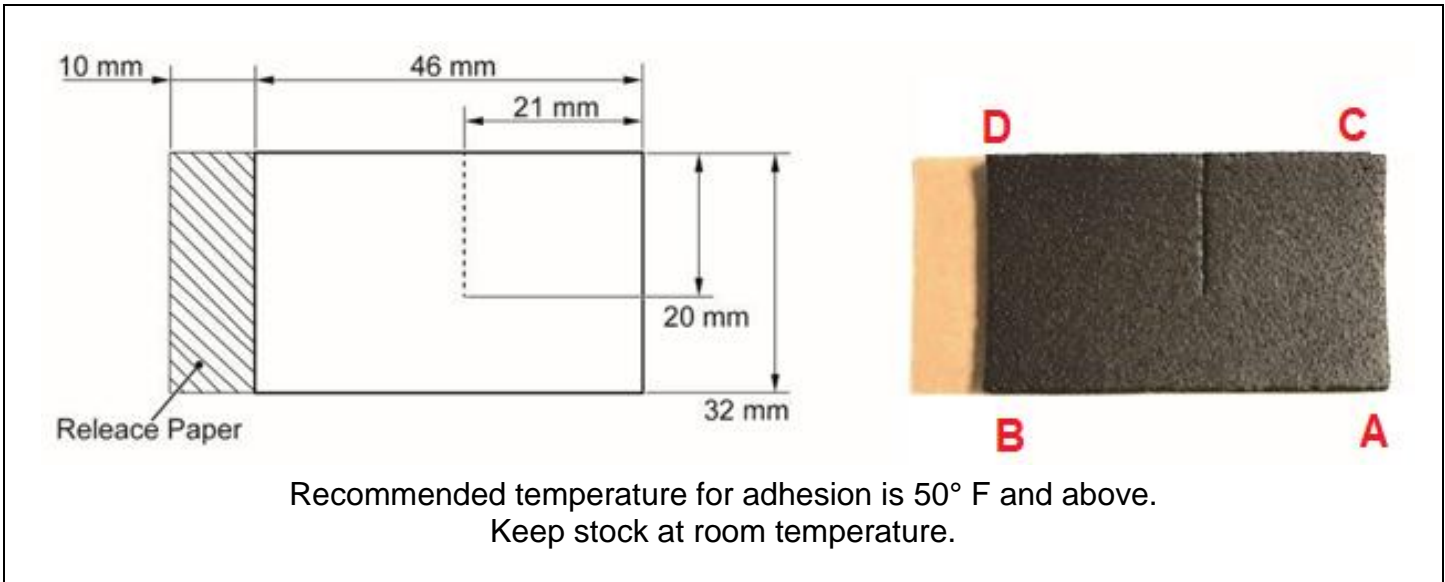
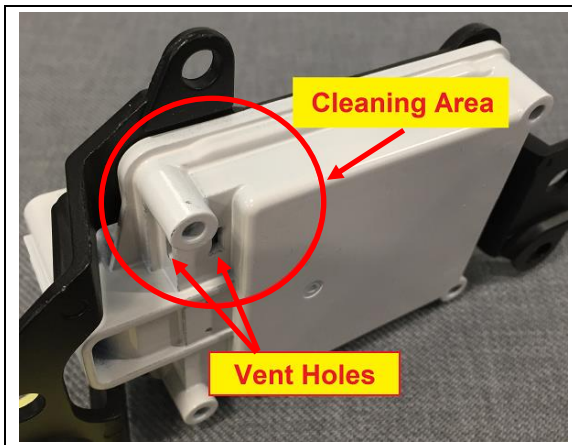
The EPT-Sealer will be applied in a specific way, using the following points for orientation. Please note the arrangement of corners A, B, C, D.

5. APPLY EPT-SEALER TO MWRS

Note: This application will use P/N **88278-0C020**. (46mm x 32mm x 5mm)

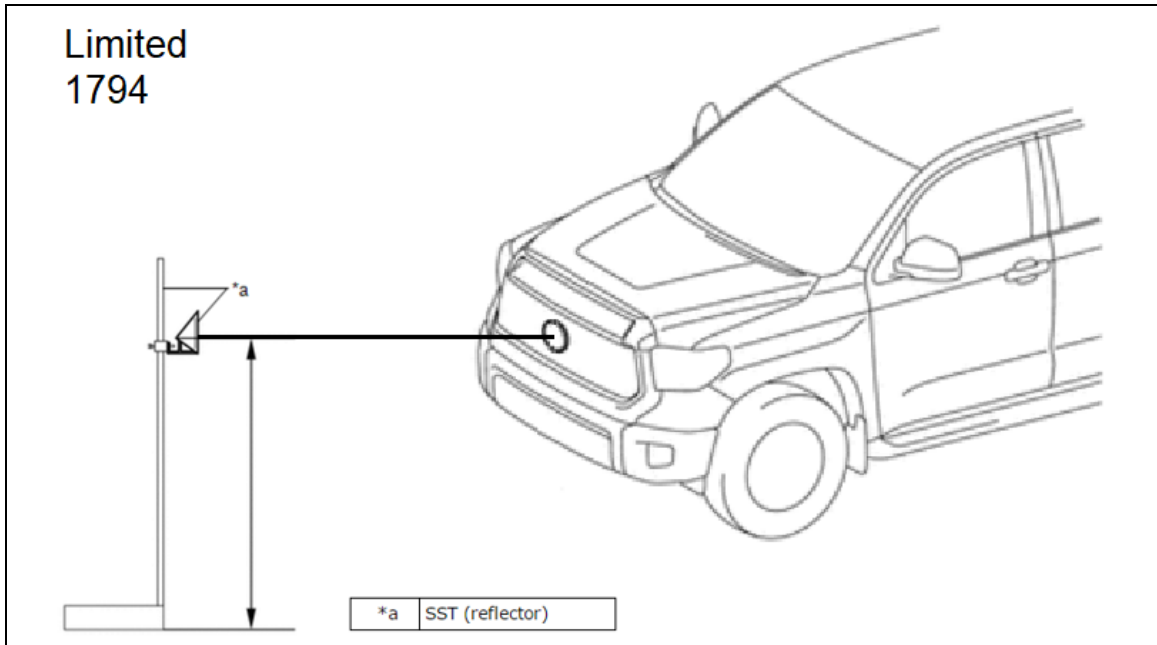
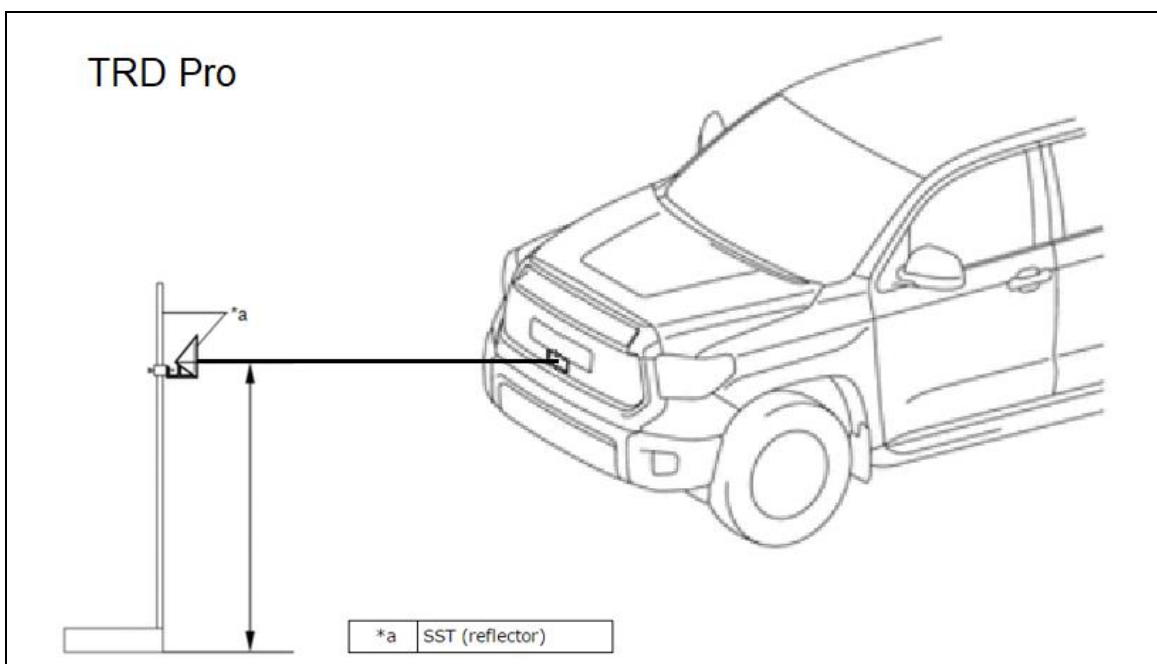
CRUISE CONTROL: MILLIMETER WAVE RADAR SENSOR: ADJUSTMENT

Because the modifications on this vehicle have changed the height of the MWRS from its original condition, it will be necessary to adjust the SST reflector height to match the height of the MWRS. When following the MWRS Adjustment procedure in the Repair Manual, change the height of the SST reflector to match the center point height of the MWRS in the grille.

- Adjust the height of the SST reflector to the center point of the MWRS in the grille.
- Follow the Repair Manual procedure to properly calibrate the MWRS.
