TITLE: Water intrusion from sealing to climate unit in plenum area

REF NO:ISSUING DEPARTMENT:TJ 32040.2.1Technical Service			ARKET: s and Canada
3 US 7	PARTNER: 7510 Volvo Car USA	ISSUE DATE: 2019-05-14	STATUS DATE: 2019-05-20
FUNC GROUP:FUNC DESC:8700Air conditioning unit		Page ⁻	1 of 22

VOLVO	Volvo Car Customer Service	TJ Instruction VC	C-497457-2
Title	Air inlet housing	Page	1 (10)
Action	Adjustment	Operation number:	99400-2
			97174-2
			36050-2

VOLVO	Volvo Car Customer Service	TJ Instruction VC	C-497457-3
Title	Air inlet housing	Page	1(10)
Action	Adjustment	Operation number:	36050-2
			97174-2
			99400-2

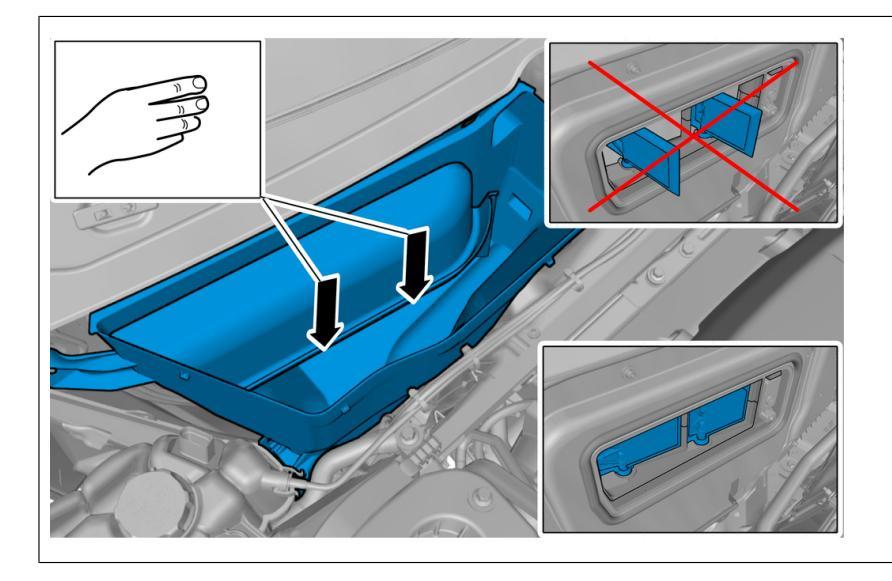
Caution! Make sure that the flaps have reached service position (closed).

Check with your hand that the flaps have closed. If not, run the script for Service position. Do not force the flaps closed by hand!

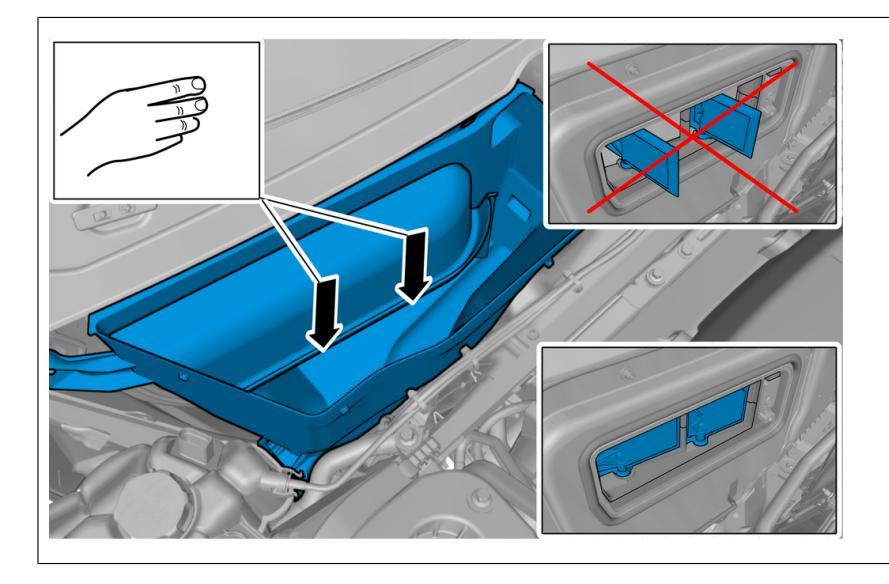
Caution! Make sure that the flaps have reached service position (closed).

Check with your hand that the flaps have closed. If not, run the script for Service position. Do not force the flaps closed by hand!
