## SERVICE BULLETIN

**APPLICABILITY:** 2017-2019MY Impreza  
 2018-19MY Crosstrek  
 2018-19MY Legacy and Outback  
 2019MY WRX and WRX STI  
 2019MY Ascent  
 2018-19MY BRZ

**NUMBER:** 15-221-18R

**SUBJECT:** Harman Audio / Infotainment: Harman Generation 3.0 and 3.1 Operating Tips

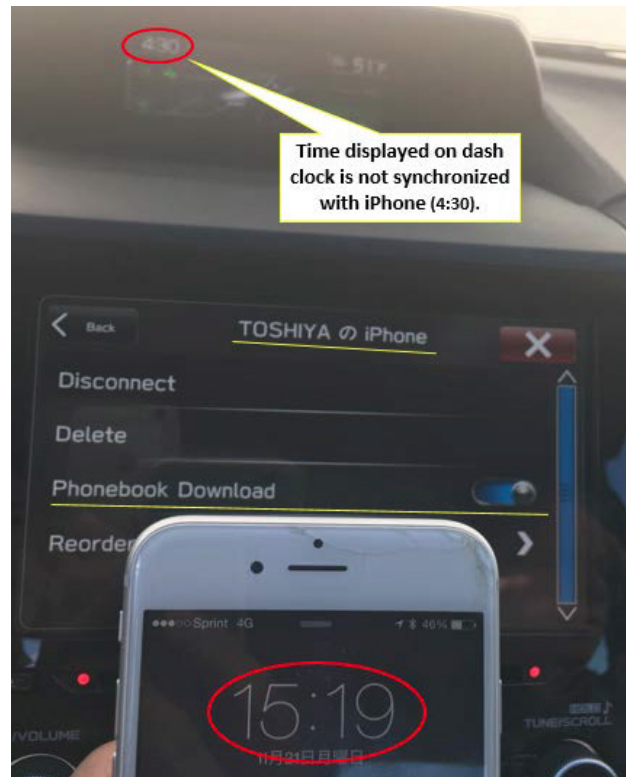
**CONDITION# 2:** Display Audio (non-navigation units), clock not synchronized with paired iPhone. (December 2016 TechTIPS).

**CAUSE: NOTE:** This information is applicable to iPhone (iOS) users only. If a customer states the time displayed on their iPhone is not synchronized with the instrument panel clock display, the information below provides an easy solution. Always ensure the latest software version is installed.

**RECOMMENDATIONS:** First, select the setting mode for the clock by following these steps:

- Press the “Home” button on the audio unit display.
- Press “Settings”.
- Press “Vehicle”.
- Select “Clock Adjustment”.
- Select “Auto”.

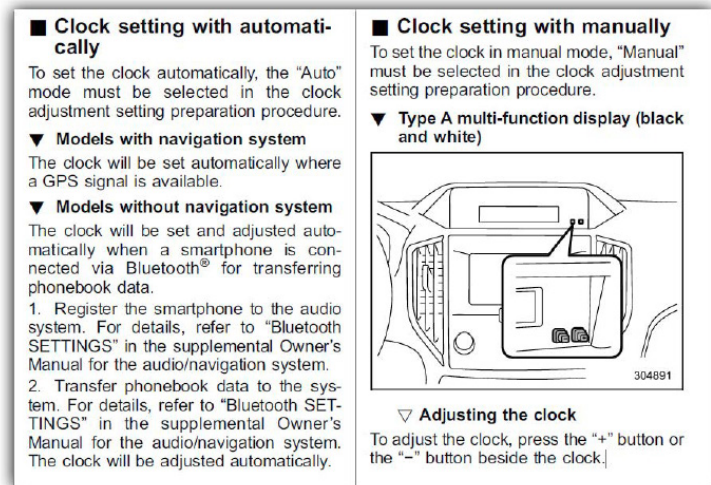
Figure 1 – 2017 Impreza Owner's Manual

**CONDITION# 3:** Clock Setting Information (December 2016 TechTIPS)

**CAUSE:** With the release of the 2017 Impreza Harman Gen 3 SUBARU STARLINK™ 6.5" Multimedia System and SUBARU STARLINK™ 8.0" Multimedia Navigation systems, there have been inquiries about the clock adjustment. There are two different modes of adjustment available: Automatic and Manual.

**Figure 1** shown here is an excerpt from the 2017 Impreza Owner's Manual describing both modes.

**RECOMMENDATIONS:** Automatic setting of the clock is accomplished differently between the navigation and non-navigation systems. As shown above, the navigation system will automatically set the time according to GPS location. Non-navigation systems utilize a paired smartphone connected via Bluetooth to accomplish the automatic setting. During the PDI process, it is recommended to manually set the clock on non-navigation models. This will ensure the correct time is displayed and allows the opportunity to show the customer the automatic feature should they choose to use it. Please review the Owner's Manual for the applicable manual clock setting procedure.

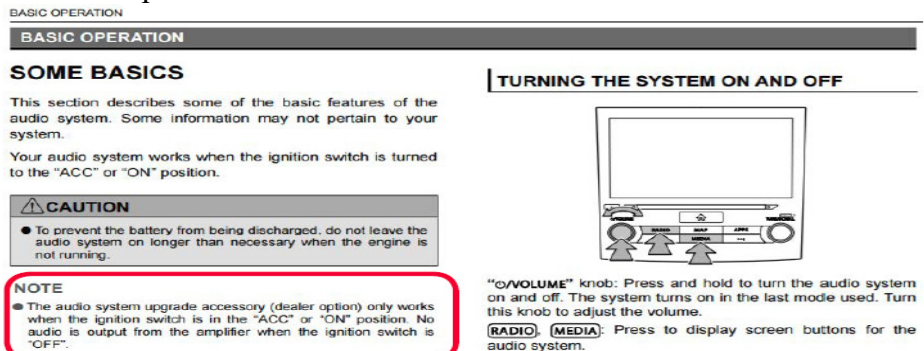
**CONDITION# 4:** Audio unit stays powered up after ignition switched to Off (February 2017 TechTIPS).

**CAUSE:** All the new 2017MY Impreza audio systems include a feature where the audio system stays powered for a period of time after the ignition is switched OFF. If the vehicle has been equipped with the accessory Rockford Fosgate audio amplifier, some confusion may arise when comparing audio unit operation of one Impreza to another. Although the audio unit will continue to operate after the ignition is switched OFF on all models, the power supply for the accessory amplifier is switched off along with the ignition resulting in the loss of audio output. This may cause confusion for customers when seeing the audio unit appear to be operating but not hearing any audio output.

Be advised, this is a normal operating characteristic and no attempt should be made to repair or replace any of the system components. **This operating characteristic is also briefly described on pg. 118 of the Multimedia System guide contained in the Owner Information Kit as shown here.**
