SERVICE BULLETIN

APPLICABILITY: 2019MY Forester
SUBJECT: Rattling Sound from Front Door

NUMBER: 12-263-19
DATE: 05/13/19

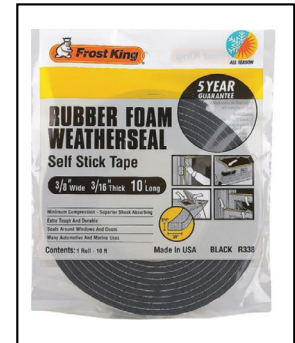
This bulletin provides a procedure to address a rattling -type sound heard coming from the front door(s). In some cases, the plastic sensor plate mounted to the inner door panel may rattle against the steel structure. The service procedure involves removing the sensor plate and adding a section of self-adhesive EPT foam sealer to alleviate the condition. The EPT sealer is now included on the replacement sensor plate part and will also be incorporated into future production.

NOTE: The PLATE-SENSOR part number information above is provided in case plate replacement is needed. The proper service procedure for this repair involves adding a piece of the EPT foam sealer to the existing plate to alleviate the rattling sound.
