PRODUCT CAMPAIGN BULLETIN

APPLICABILITY: 2009-2013 Forester
 2008-2014 Impreza
 2005-2014 Legacy
 2005-2014 Outback
 2006-2008 Tribeca

NUMBER: WUF-91R
NHTSA: 19V-297
DATE: 04/15/19
REVISED: 05/22/19

SUBJECT: Replacement Ignition Switch Recall

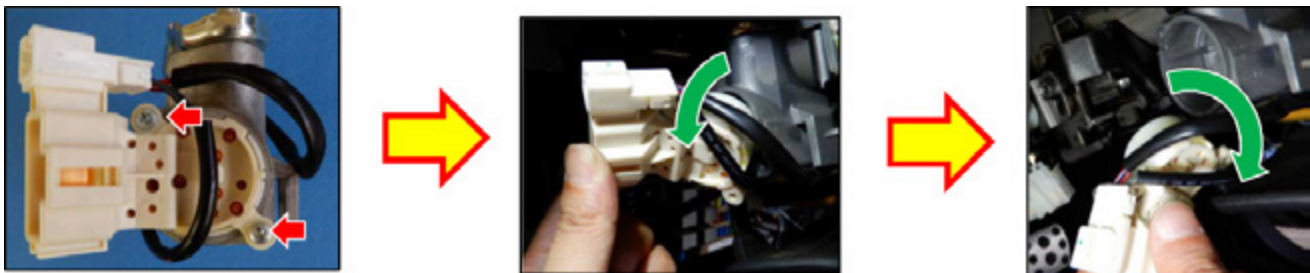
CAUTION: The harness for the key lock solenoid is routed around the ignition lock assembly. After CAREFULLY disconnecting the harness connector, do not pull on, reposition or un-twist the key lock solenoid harness any more than necessary to facilitate removing the ignition switch from ignition lock assembly.

2. Remove the two (2) ignition switch Philips head retaining screws.

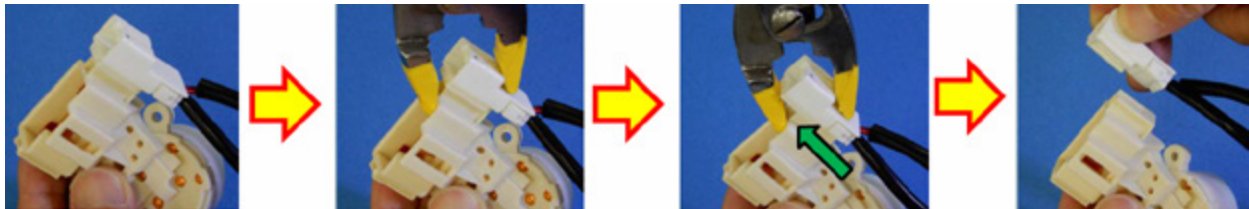
- If replacing the ignition switch on one of these models, **CAREFULLY** removing the key lock solenoid connector from the ignition switch by using pliers as shown below and swap it over to the new switch. Apply electrical tape to the plier jaws to protect the connector.
- If the connector or wiring is damaged, the ignition steering lock assembly will require replacement including recoding of the new assembly to match the original keys by a certified locksmith.
- **NOTE:** Removing the key lock solenoid connector, as shown in the sequence below, is only required if the ignition switch requires replacement.

5. **CAUTION:** After reinstalling the ignition switch back into the lock housing, torque the 2 retaining screws to 1.1 Nm (9.7 inch-pounds). **DO NOT OVER-TIGHTEN.** Confirm all functions of the ignition switch (OFF, ACC, ON, and START). With the engine OFF and parking brake fully engaged, confirm the function of the ignition interlock by attempting key removal in a gear other than park. Proceed to **Step 5** below.

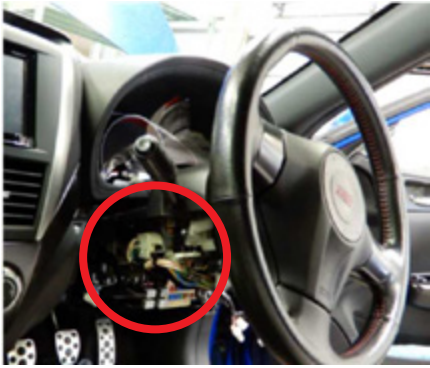
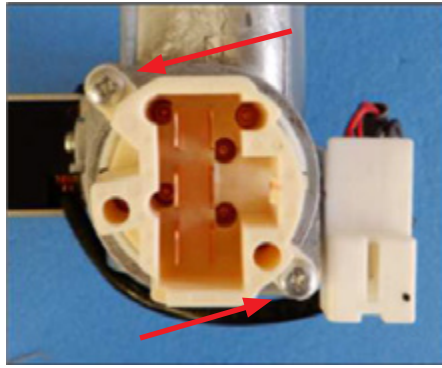
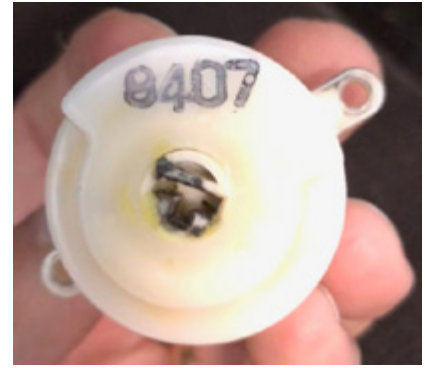
Using the chart above as a guide, if the Lot Number is between **6Z18** (December 18, 2016) and **7602** (June 2, 2017), the ignition switch MUST be replaced. **NOTE:** If the Lot Number is illegible, **REPLACE** the ignition switch assembly.

- For **2008-2009MY Legacy, Outback, & 2008-2014MY Impreza, WRX, STI and Forester Models:**
 1. Remove the harness connector from the ignition switch.
 2. Remove the two (2) ignition switch Philips head retaining screws.

3. Remove the ignition switch from the ignition lock assembly.
4. Confirm the Lot Number on the face of the ignition switch using the chart below.

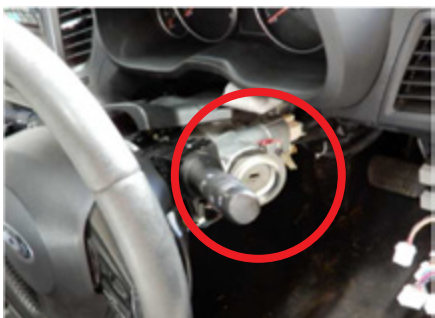
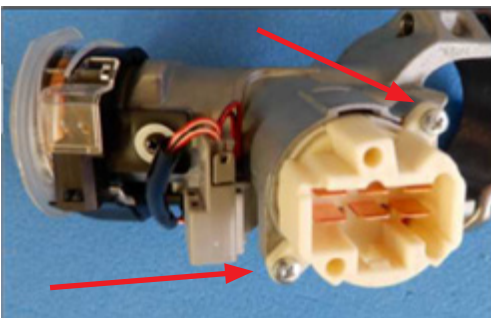
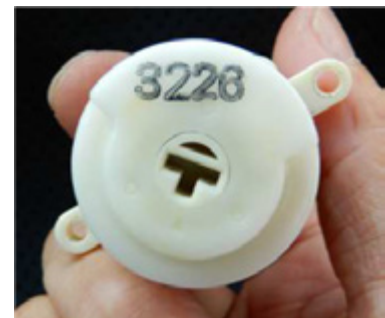
Using the chart above as a guide, if the Lot Number is between **6Z18** (December 18, 2016) and **7602** (June 2, 2017), the ignition switch **MUST** be replaced. **NOTE:** If the Lot Number is illegible, REPLACE the ignition switch assembly.

1. Remove the harness connector from the ignition switch.
2. Remove the two (2) Philips head retaining screws.

3. Remove the ignition switch from the ignition lock assembly.

5. **CAUTION:** After reinstalling the ignition switch back into the lock housing, torque the 2 retaining screws to 1.1 Nm (9.7 inch-pounds). **DO NOT OVER-TIGHTEN.** Confirm all functions of the ignition switch (OFF, ACC, ON, and START). With the engine OFF and parking brake fully engaged, confirm the function of the ignition interlock by attempting key removal in a gear other than park. Proceed to **Step 5** below.
