Field campaign

Topic	Rear Seat Entertainment - field update 2 (SC18/02) (ASW 09.16)
Market area	Bentley: worldwide (2WBE),Hongkong-Macau (5HK)
Brand	Bentley
Transaction No.	2048661/5
Campaign number	EA98
Note	
Type	Service Campaign
US code

Flying Spur

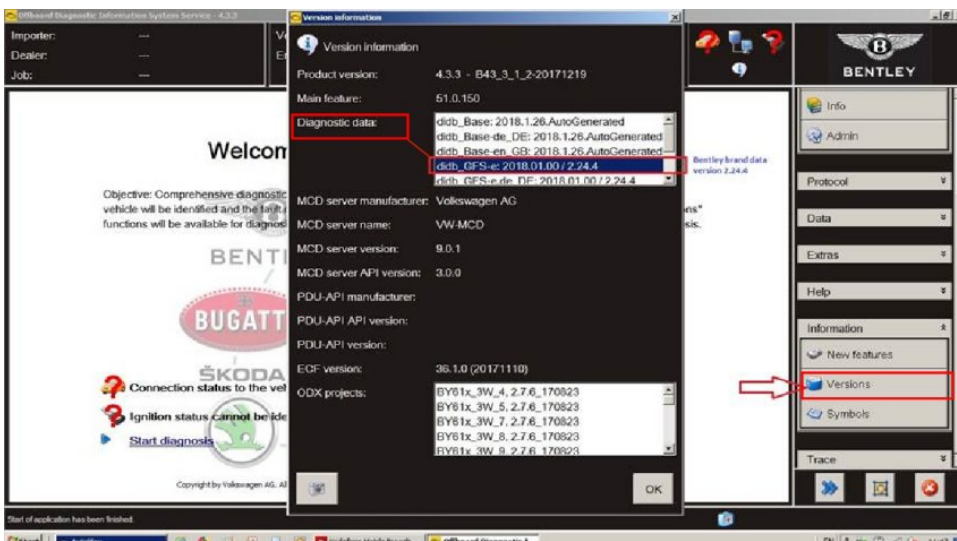
Figure 1a

Your Bentley diagnostic tester must be loaded with Bentley Brand Diagnostic Data Version (didb version) 2.24.4 or higher to perform this campaign (see Figure 1a)
