Service Bulletin

Bulletin No.: 18-NA-195

Subject: Radio Module Software Update 20.11

Brand:	Model:	Model Year:		VIN:		Engine:	Transmission:
		from	to	from	to		
Cadillac	ATS	2018	2018			All	All
	CTS						
	XTS						
GMC	Terrain	2018	2018			All	All

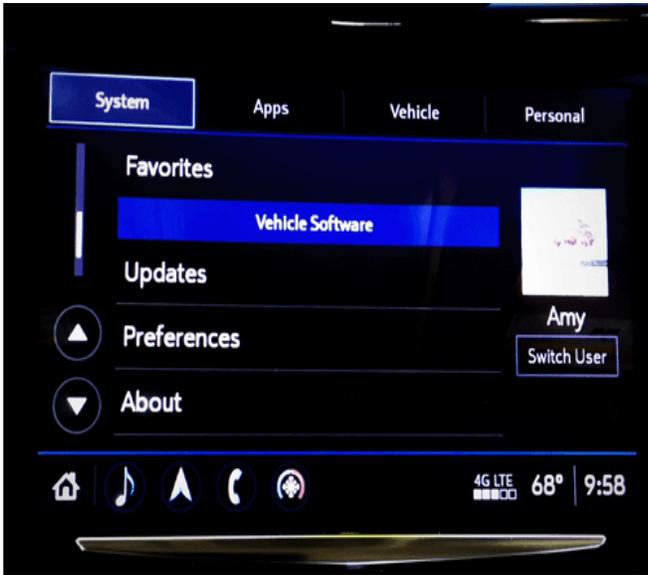
4880811

- If the remote vehicle update has not been downloaded, select “Start Download” as shown above.

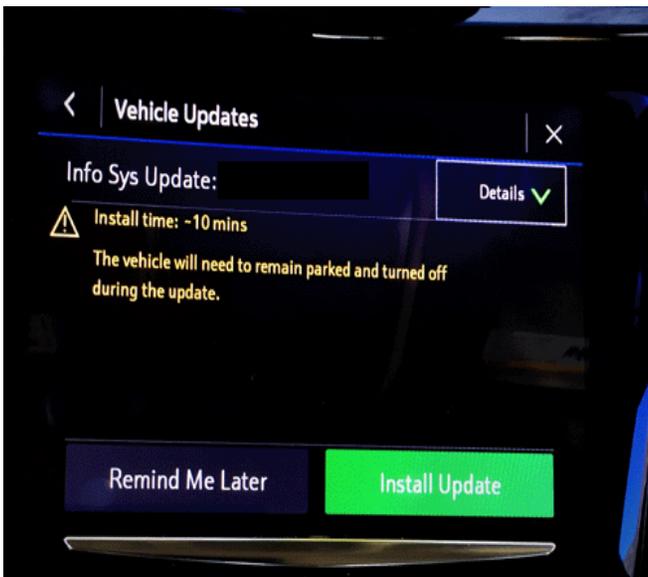
4880822

- If the vehicle needs to download the remote vehicle update file or the “Install Update” screen does not appear, select “Settings”, scroll down to “Updates” and select “Updates” to download the remote vehicle update.
- If there are no updates available, verify the software version. If the build number is less than 20.11 (i.e. 20.9 or 20.10), update through USB.

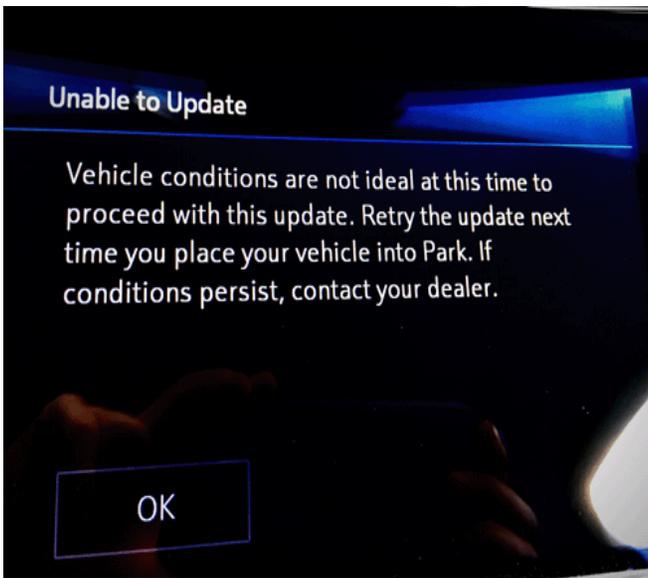
4880804

If the Vehicle Updates screen shows a blank update title, follow steps 1 and 2 of the “Update Procedure Using SPS” to decline the package and then proceed with USB programming.
