CR178 Ducati Quick Shift sensor cable re-routing

Multistrada 950 S MY 2019

Multistrada 1260 S (all model versions) MY 2019

Technical Service Bulletin SRV-TSB-19-007

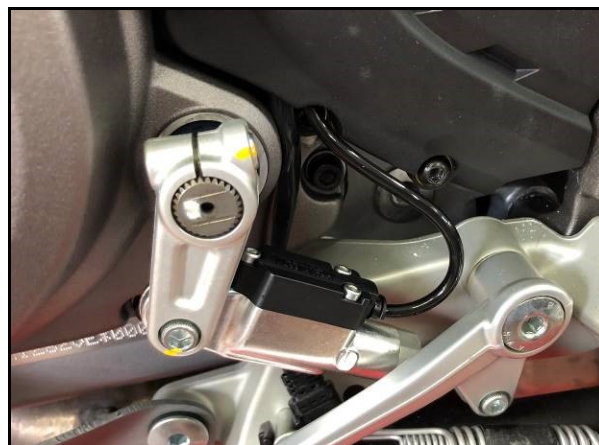
Ongoing product testing and reports from the dealer service network have identified the potential improper installation of the Quick Shift sensor cable (DQS). The DQS sensor cable could be slightly stretched (mainly when the gearchange lever is operated), with a consequent possible internal damage causing the following errors:

- **P0827:** Ducati Quick Shift sensor error [Short circuit to ground]
- **P0828:** Ducati Quick Shift sensor error [Short circuit to positive]

The motorcycles involved in this Service Campaign must be inspected and the DQS sensor cable must be re-routed if needed to ensure the correct operation of the system.

In case of accessory DQS sensor assembly for the Standard versions, ensure the cable is routed as described in this bulletin.
