Technical Service Bulletin

| Technical Service Bulletin: TSB170002 | Released Date: 07-May-2019 |
| Injector Sleeve Seal Leakage Causing Fuel and Coolant Cross-Contamination | |

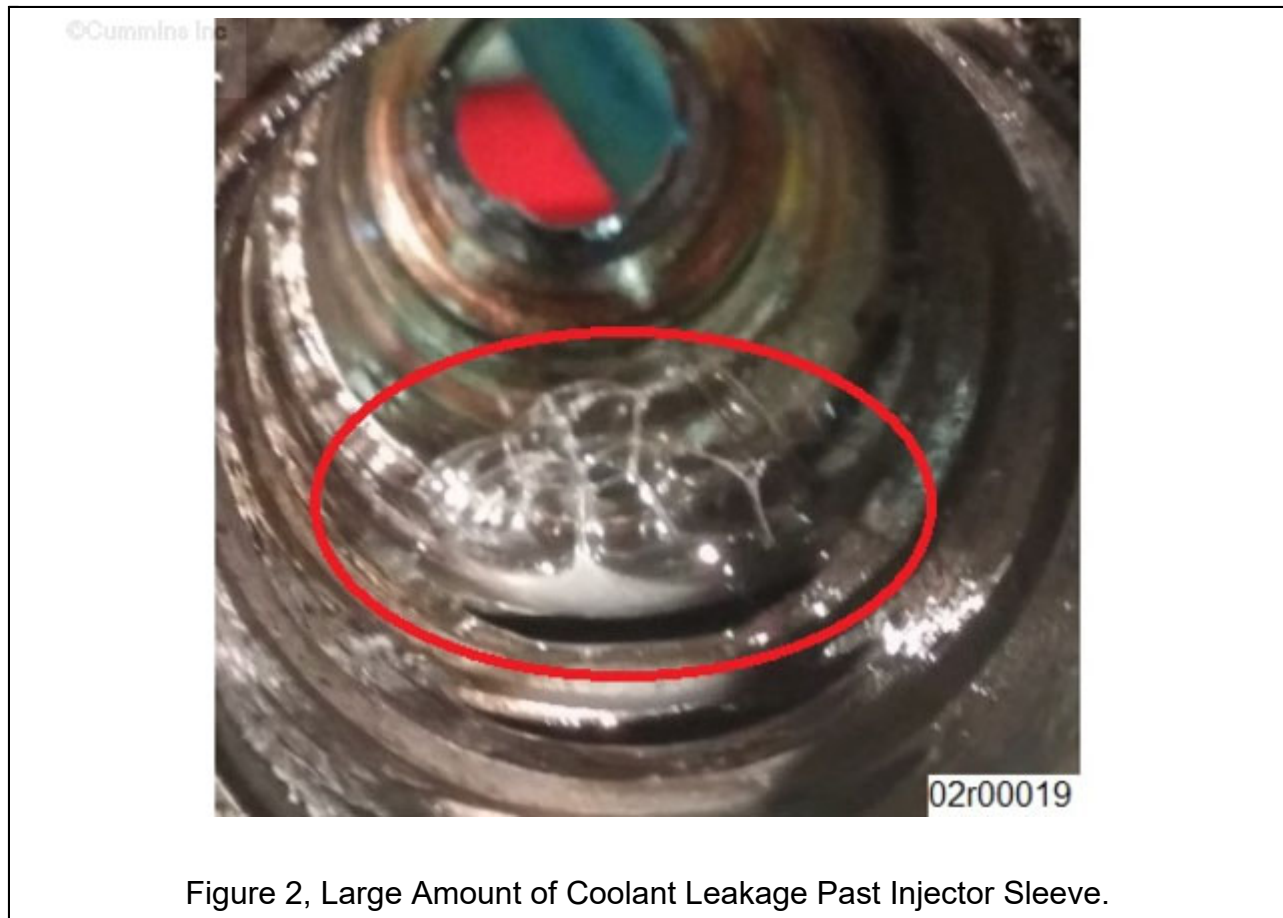
- Shrinkage of injector sleeve seal material can create a leak path between cylinder head cooling jacket and injector bore.

Figure 1, Small Amount of Coolant Leakage Past Injector Sleeve.

- Cylinder head assemblies are **not** to be replaced if injector sleeve is found leaking.
- If leaking injector sleeve is root cause of coolant or fuel cross-contamination, install retaining ring, Part Number 4312298 in all six injector sleeves. See Service Instructions and Service Parts Availability Sections below.
- Even if **only** one injector sleeve is found leaking, retaining rings **must** be installed in all six injector sleeves.
- Installation of a retaining ring is a onetime repair **only**. If an injector sleeve is found to be leaking again and a retaining ring was previously installed, Service Manual Procedure 002-014 in Section 2 will direct further investigation of cylinder head to better understand severity of fuel or coolant leak or causes besides sleeve seal material being compromised.
- Inspect the fuel tank and filter for contamination.
