WKEO - Retrofitting Relay for Activating Control Unit for Air-Conditioning Blower (Workshop Campaign)

Model line: **Panamera (970)**

Model Year: **As of 2010 up to 2016**

Subject: **Control unit for air-conditioning blower**

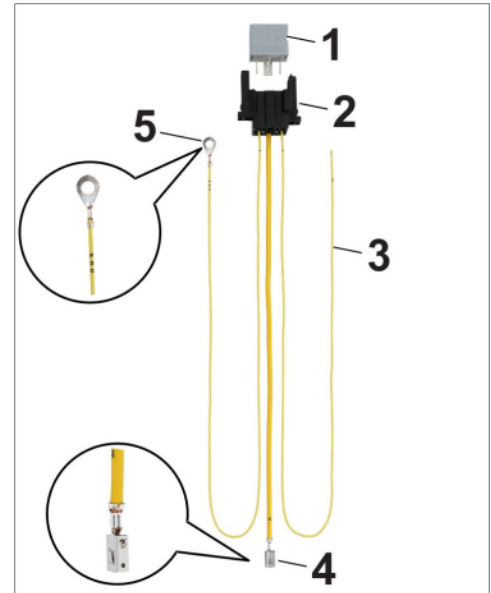
- 1 – Relay
- 2 – Relay socket
- 3 – Cable (0.5 mm²)
- 4 – Cable (4 mm²) with flat contact
- 5 – Cable (1 mm²) with cable shoe

Overview of relay repair kit
