TECHNICAL INSTRUCTIONS FOR SPECIAL SERVICE CAMPAIGN K0B MILLIMETER WAVE RADAR SENSOR

**CERTAIN:
2018 – 2019 TACOMA
2018 – 2019 TUNDRA**

Update 4/2/2019: Instructions provided for Tacoma Bar Type grill EPT Sealer application. Correction made to the Tundra TRD Pro grill photo.

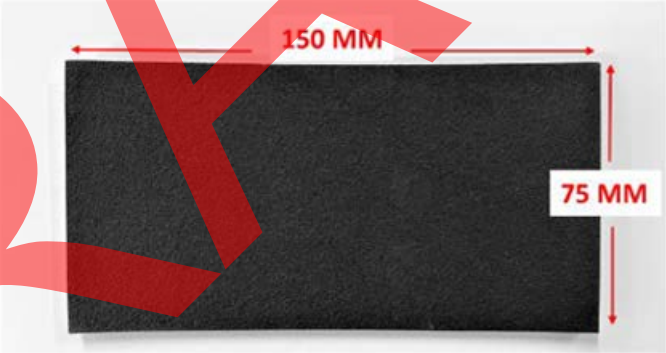
Part Number	Part Description	Quantity
88278-0C010	Cushion, Skid control Computer (EPT Sealer Repair A: 75 mm x 150 mm, t = 5 mm)	1

Recommended temperature for adhesion is 50° F and above.
Keep stock at room temperature.

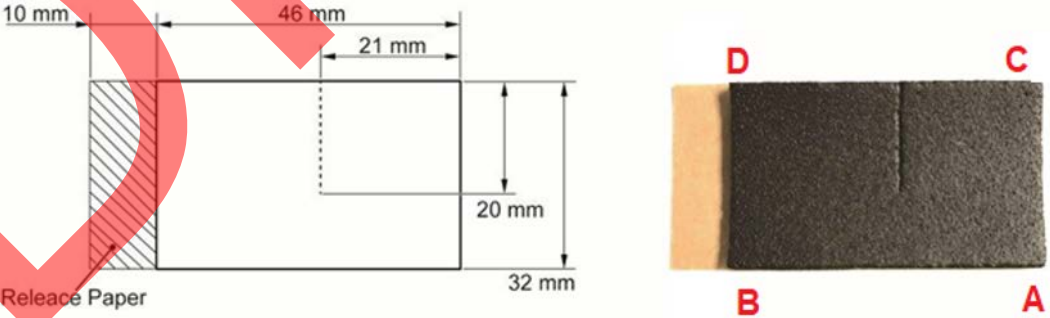
Part Number	Part Description	Quantity
88278-0C020	Cushion, Skid control Computer (EPT Sealer Repair B: 46 mm x 32 mm, t = 3 mm)	1

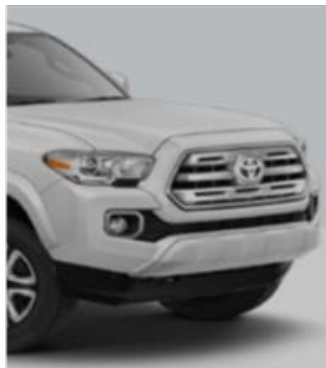
This process is only for Tacoma's with the Bar type grill:

a. Apply the EPT Sealer to the back side of the MWRS in the position shown below:

- Start applying the EPT Sealer sheet to the vertical surface of the radiator grill, just above the MWRS.
- It will be necessary to push the EPT Sealer into the plastic tab at the top, creating a hole in the sealer.
- Wrap the EPT Sealer around the wire harness, as shown.
- Using heavy finger pressure, thoroughly press the entire surface of the EPT sealer to securely adhere it to all contact surfaces of the MWRS and grill.

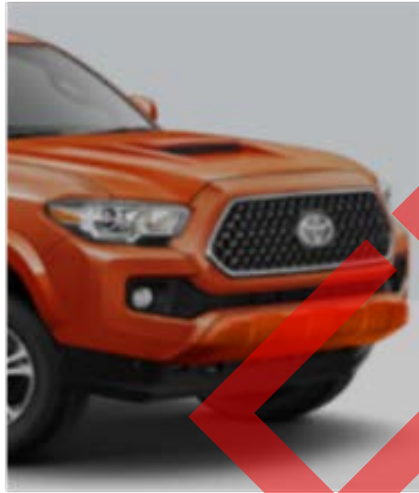
This process is only for Tacoma's with the Mesh type grill:

b. Apply the EPT Sealer to the back side of the MWRS in the position shown below:

- Start applying the EPT Sealer sheet to the horizontal lip of the radiator grill to create a waterproof shield over the top of the sensor.
- Using heavy finger pressure, thoroughly press the entire surface of the EPT sealer to securely adhere it to all contact surfaces of the MWRS.
