**URGENT REMINDER: ProMaster Transmission Bracket Service**

May 29, 2019

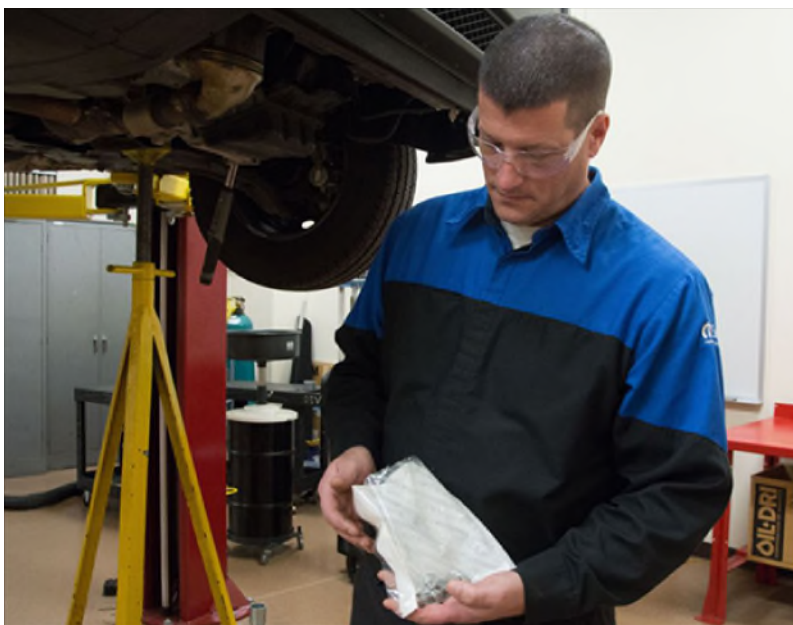
When servicing a Ram ProMaster equipped with a 3.6L engine, this notice is to emphasize the importance of **replacing** the **one-time use** bolts that fasten the left transmission mount to the transmission.

**WARNING: DO NOT reuse these transmission mount bolts, as it may lead to future catastrophic damages.**

Be sure to check all mounting bracket torque specifications -- some fasteners have a torque value higher than most bolts

*Replace the bracket on any ProMaster with a VIN built before 10/23/2015.*
