NUMBER: 08-045-19

Flash Over The Air (FOTA) Software Update UAV and UCV Radio

This bulletin provides information regarding the latest FOTA software update to 21.10.

2019 (DT) RAM 1500 Pickup

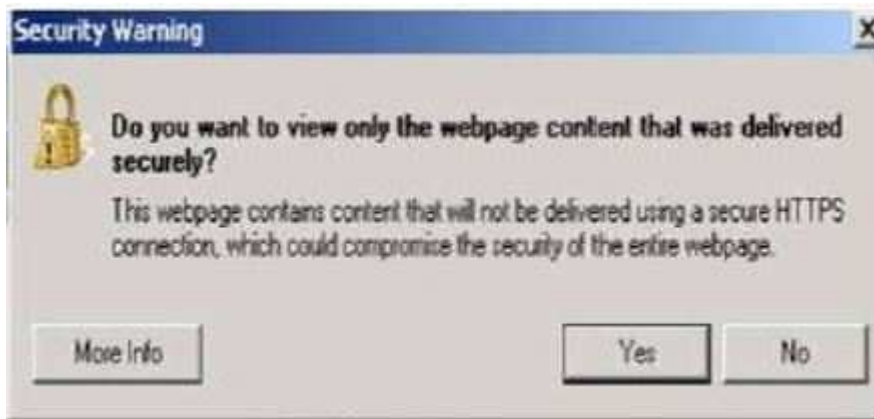
Fig. 2
Pop-Up Security Message

2. Go to DealerCONNECT>Service>Uconnect Command Center>Uconnect>More Information >Dealer software downloads to download the files.
3. If a security message appears “Do you want to view only the webpage content that was delivered securely?” ([Fig. 2](#)) . Press “No” to continue.

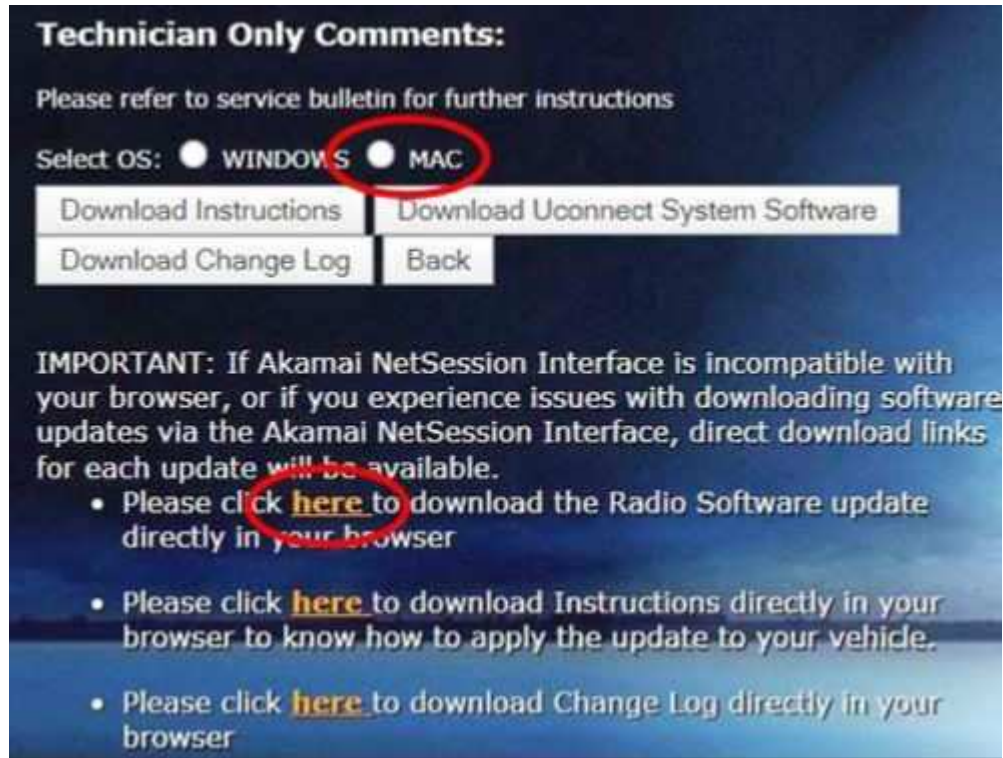
Fig. 3

5. Download the software update file to your local PC's desktop. Make sure to select the "MAC" radial button for all downloads (Fig. 3) .

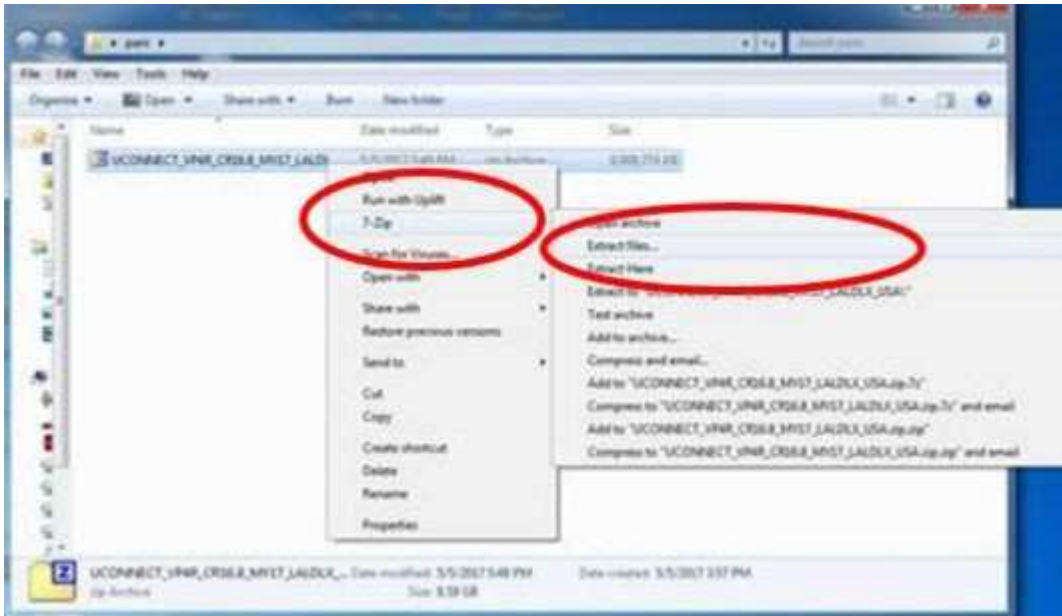
Fig. 4
Zip File Extraction

8. Extract the downloaded zip file to the designated USB flash drive (Fig. 4) and (Fig. 5) .
NOTE: It may take a few minutes for an accurate extract time to be displayed.

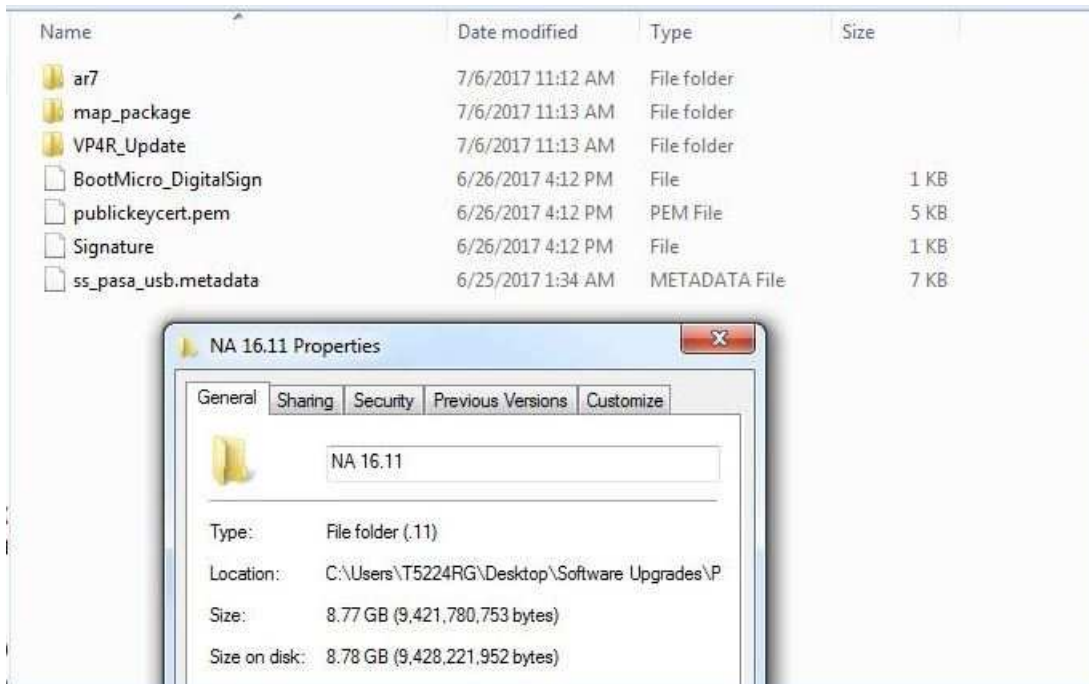
Fig. 6
Navigation Radio Files

9. Verify the content on the flash drive matches (Fig. 6) for Navigation equipped radios and (Fig. 7) for Non-Navigation equipped radios.

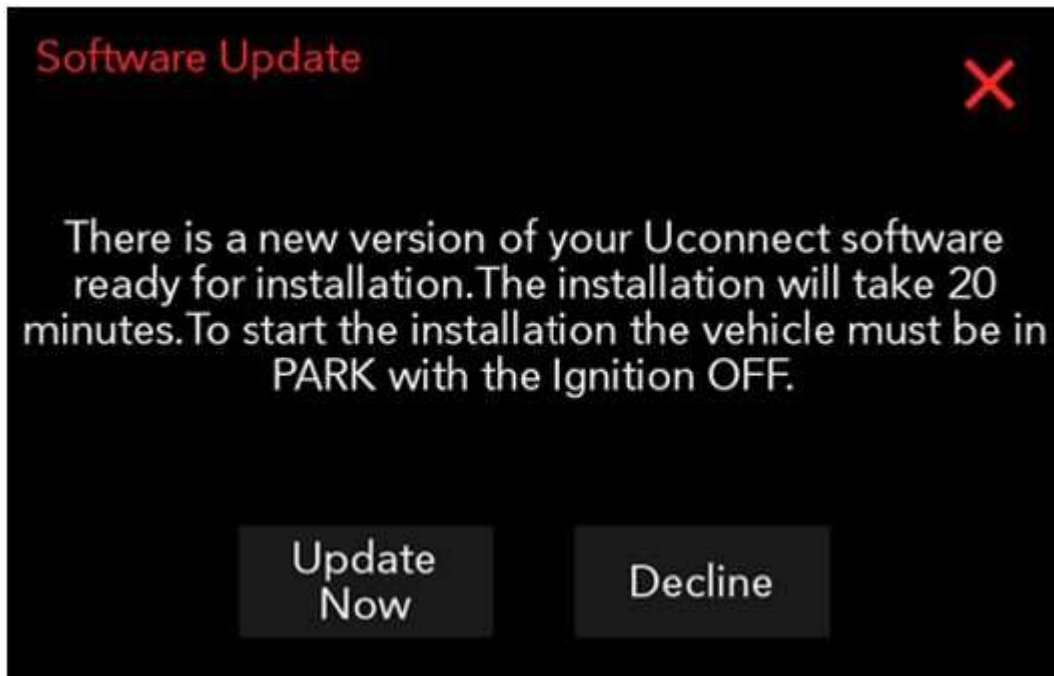
Fig. 9
Software Update Is Available

13. Once the system has verified there is an available update, touch the “Update Now” button. Make sure the vehicle is in park, **DO NOT turn off the ignition** (Fig. 9) .

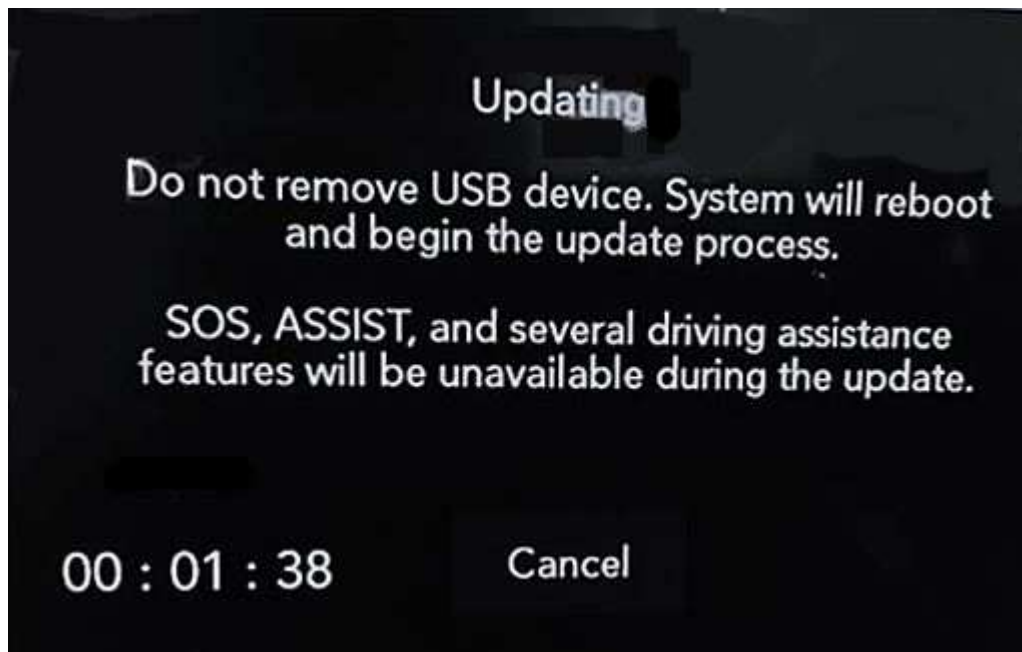
Fig. 10
Radio Update Process Begins

14. If the ignition is turned off before the two minute has expired, the software update will be canceled (Fig. 10) .

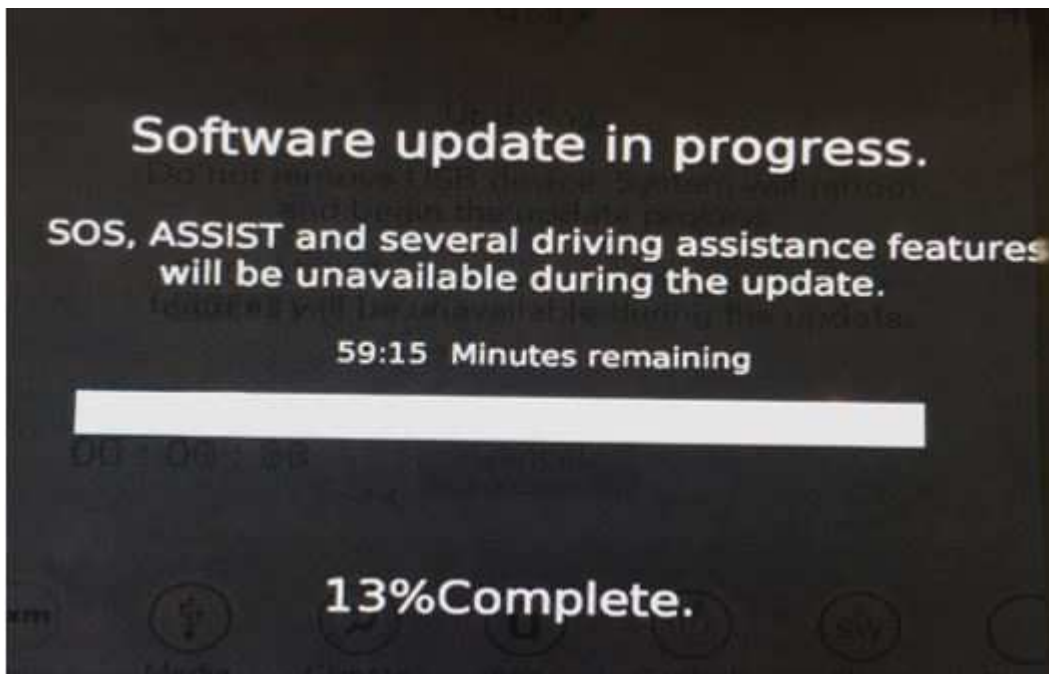
Fig. 11
Software Update In Progress

15. The radio will reboot and the update will begin (Fig. 11) .
