NUMBER: 08-051-19

UJQ with RS9 Radio Enhancements

This bulletin involves inspecting and if required, updating the radio software level to ****21.9.****

2018 - **2019**	(LA)	Dodge Challenger
2018 - **2019**	(LD)	Dodge Charger
2018 - **2019**	(LX)	Chrysler 300

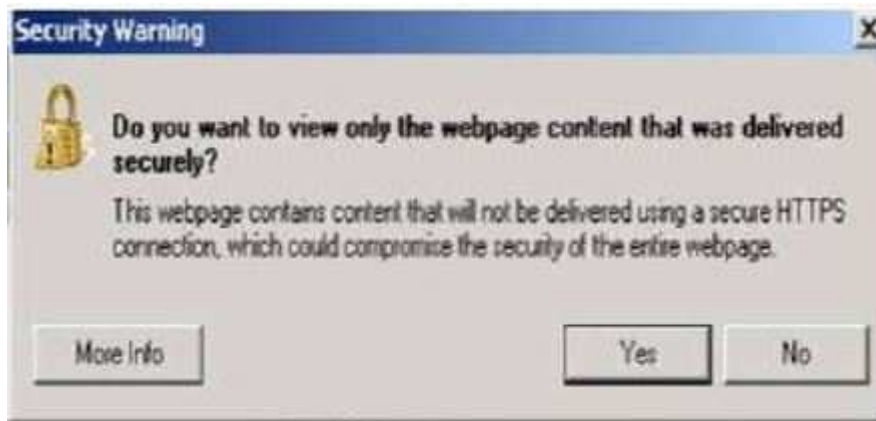
Fig. 2
Pop-Up Security Message

3. If a security message appears “Do you want to view only the web page content that was delivered securely?” (Fig. 2) . Press “No” to continue.

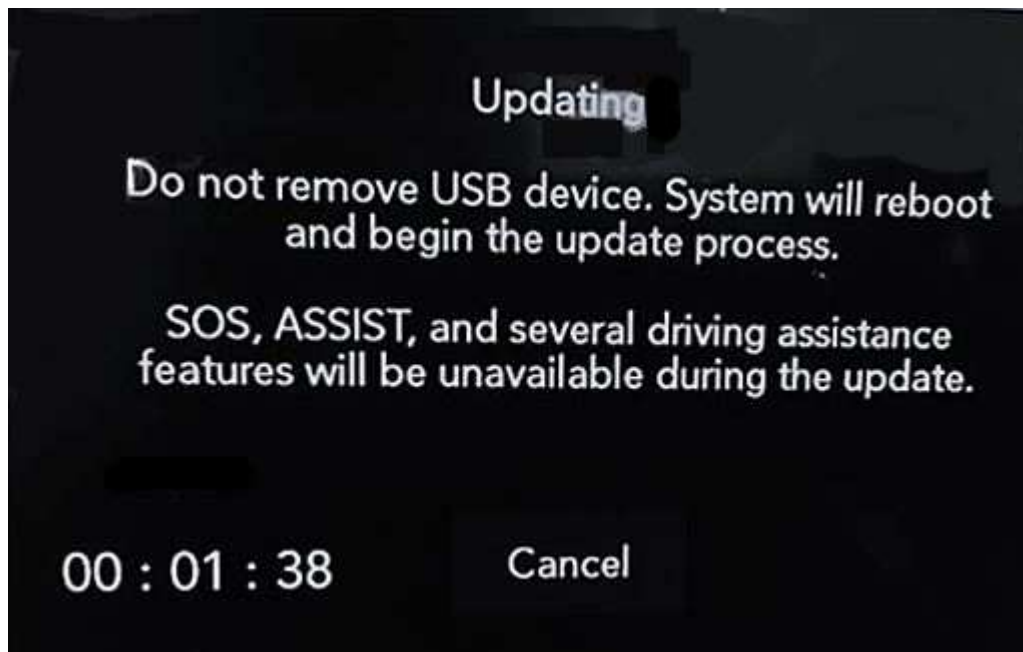
Fig. 10
Radio Update Process Begins

14. If the ignition is turned off before the two minute has expired, the software update will be canceled (Fig. 10) .

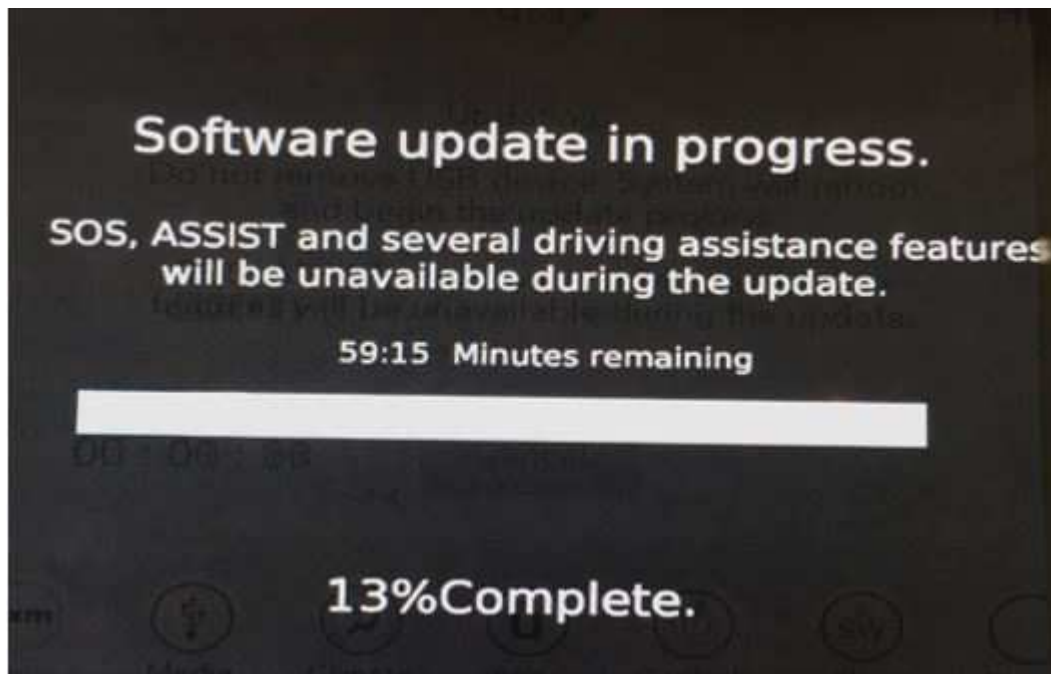
Fig. 11

Software Update In Progress

15. The radio will reboot and the update will begin (Fig. 11) .
