**Campaign code:**L636-B.09.19**Campaign Name:**Gateway Update**Model:**Urus**Model year:**From 2019**Special or limited editions:**All versions**Markets:**Only NAR market**VIN identification:**From KLA02065 to KLA04068

As a result of the continuous monitoring of the product, Automobili Lamborghini S.p.A. has released a new update for the Gateway ECU of Urus. This update contains improvements for vehicle ignition management.

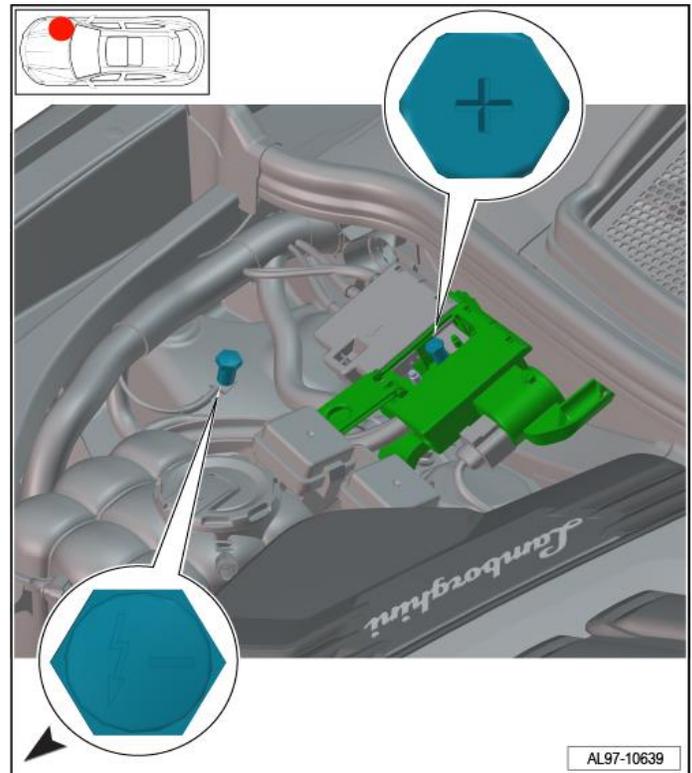
- It is essential that you connect an appropriate battery charger to the charge points available in the engine hood (left side of the vehicle). Please refer to the following figure.
