L73X-A.03.19.

Pydos ECU flash and instrument cluster update.

Aventador.

To: Official After Sales Network
Subject: Pydos ECU flash and instrument cluster update
Date: 21 June 2019
Pages: 25

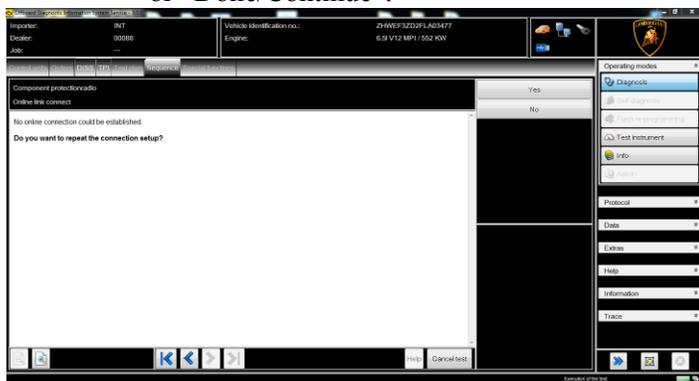
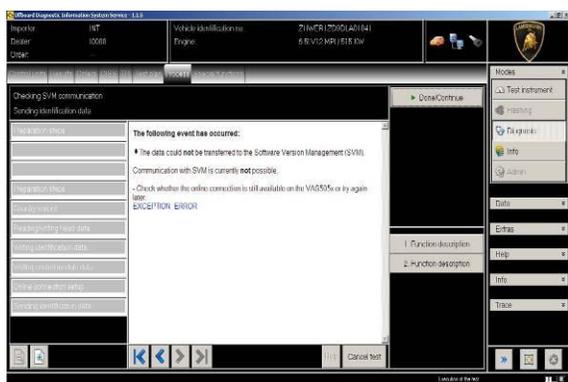
iii. If one of the connection error screens is shown as in the pictures below:

- it is not possible to establish a connection with the central server. Please check carefully that the diagnosis laptop is properly connected to the internet network and retry clicking “Yes” or “Done/Continue”.

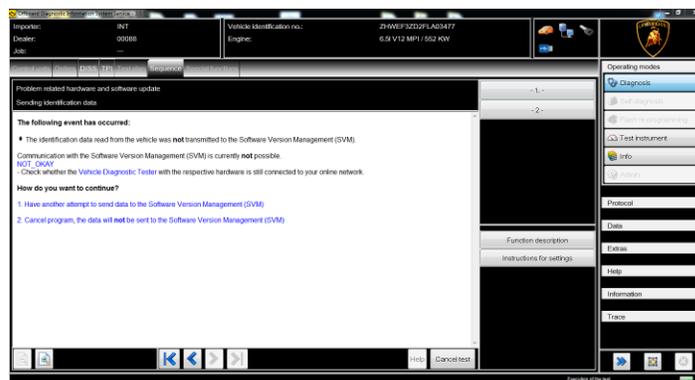
iv. If the loss of connection happens during the target/actual comparison during SVM procedure:

- It is not possible to connect to central server, check the working connection of internet and retry by clicking “1”.

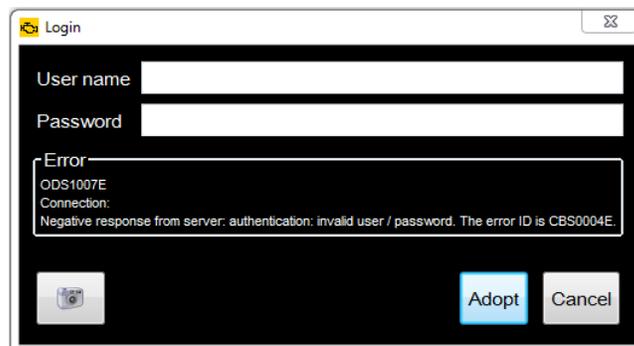
v. If the incorrect identification message is shown as in the picture below (error code: ODS1007E):

- be sure that your Geko account is valid;
- be sure that the label “Geko” is written on the token that you are using for the authentication;
- be sure the Password inserted is correct;
- click on Cancel and perform the application test (see document “ODIS_Checking_ConnectionServer_SVM_2.0” (*)).

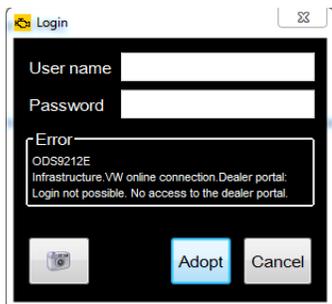
vi. If the infrastructure error message is shown as in the picture below (error code: ODS9212E):

- be sure that your Geko account is valid
- be sure that the label “Geko” is written on the token that you are using for the authentication
- verify in ODIS settings you have “Internet” instead of “CPN” (see document “ODIS_Initial_Setup_2.0” (*))
- click on Cancel and perform the application test (see document “ODIS_Checking_ConnectionServer_SVM_2.0” (*))

If the same error is present during the application test, try the following procedure:

- quit ODIS;
- Enter the folder C:\Program Files (x86)\Offboard_Diagnostic_Information_System_Service\automatic_sessions on your diagnosis laptop;
- delete the only file present in that folder.
- re-Start ODIS Service under following conditions:
 1. Network connection available;
 2. ODIS connection set on “Internet”;
- Retry the application test and the SVM with your GeKO Token.

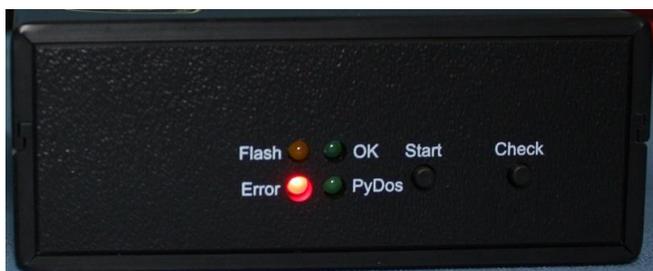
• 5.1.2 *The red “Error” LED is ON*

Status of the red Error LED	Failure
Blinking	Invalid control unit
Permanently on	Refer to the description of failure chapter
