SI B52 04 19
Seats

SECOND ROW 60/40 DRIVERS SIDE SEAT INTERMITTENTLY WON'T LATCH

| G05 (X5 Sports Activity Vehicle) | G07 (X7 SAV) | | |

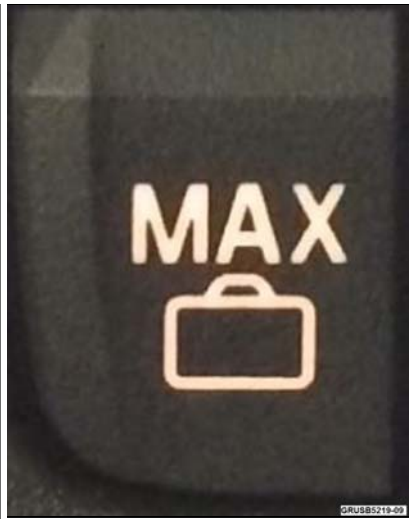
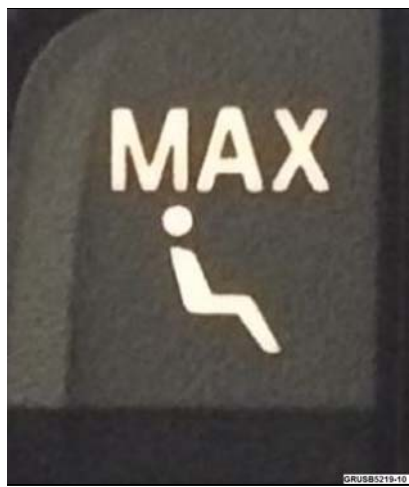
- Access the rear switches in the D pillar area
- Push the button for maximum cargo space

- Alternatively, push this button for maximum seating.
- Intended result:
- All 2nd and 3rd row seats should move
